ABOUT ADSP-21368 SILICON ANOMALIES

These anomalies represent the currently known differences between revisions of the SHARC® ADSP-21368 product(s) and the functionality specified in the ADSP-21368 data sheet(s) and the Hardware Reference book(s).

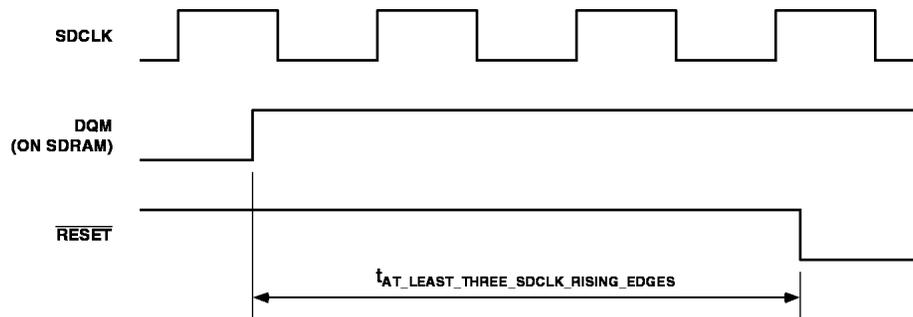
19. 08000024 - Parallel EPROM/FLASH boot following a Hard (Hot) Reset may fail if issued in the middle of external SDRAM reads:**DESCRIPTION:**

If the SHARC processor is in the process of fetching data from external SDRAM memory, initiating a Hard (hot) reset during this process may cause the SDRAM device to continue to drive the data bus during the entire duration of /RESET being asserted, and also failing to relinquish the external data bus even when the DSP comes out of /RESET.

Providing an external delay of at least 3 SDCLK clock cycles between the SDRAM's DQM signal and the /RESET_IN to the DSP will also cause the problem to be avoided (see attached Figure).
