## Silicon Anomaly List

## ADSP-BF531/BF532/BF533

### ABOUT ADSP-BF531/BF532/BF533 SILICON ANOMALIES

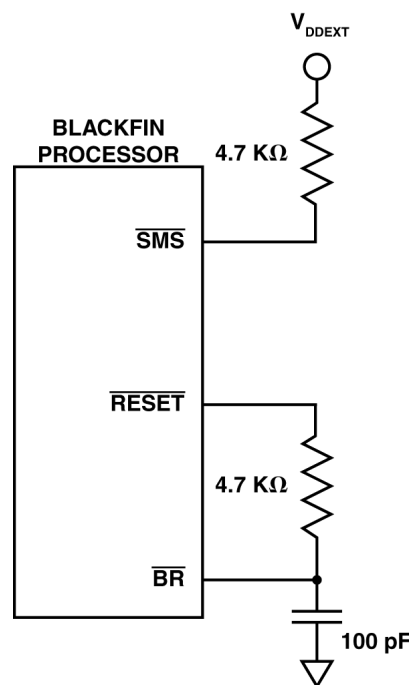
**43. 05000471 - Boot Failure When SDRAM Control Signals Toggle Coming Out Of Reset:****DESCRIPTION:**

When  $\overline{\text{RESET}}$  is de-asserted at the conclusion of the power-on reset sequence (not applicable to warm resets), there is a very small chance that the SDRAM control signals ( $\overline{\text{SRAS}}$ ,  $\overline{\text{SCAS}}$ ,  $\overline{\text{SWE}}$ ,  $\overline{\text{SMS}}$ ,  $\overline{\text{SCKE}}$ , and  $\overline{\text{SA10}}$ ) may be driven low for a single CLKOUT cycle. This activity can cause certain SDRAM devices to enter engineering test modes that result in the SDRAM driving data onto the shared EBIU data lines that the Blackfin processor is going to read from when configured to boot or execute from parallel flash.

When booting from parallel flash (BMODE = b#01), this contention corrupts the boot stream and causes the processor to hang. At this point, power-cycling the processor is required to clear the condition.

A hardware workaround can be implemented in the form of an RC delay circuit introduced between the  $\overline{\text{RESET}}$  and bus request ( $\overline{\text{BR}}$ ) pins:

The delayed version of  $\overline{\text{RESET}}$  seen on  $\overline{\text{BR}}$  causes the Blackfin processor to continue to three-state the SDRAM control signals after the rising edge of  $\overline{\text{RESET}}$  for longer than one CLKOUT cycle, which over-rides the glitch behavior described by this anomaly. The pull-up resistor on the  $\overline{\text{SMS}}$  pin ensures that the memory-select signal remains de-asserted while the processor is three-stating the  $\overline{\text{SMS}}$  output. Additional pull-ups are needed on the  $\overline{\text{AMSx}}$  signals as well. This drawing contains the local connections to the Blackfin processor only. The  $\overline{\text{RESET}}$  input pin is connected to the reset supervisor circuit, and the  $\overline{\text{SMS}}$  output pin connects to the SDRAM memory select pin.
