ABOUT ADSP-TS201S SILICON ANOMALIES

These anomalies represent the currently known differences between revisions of the TigerSHARC® ADSP-TS201S product(s) and the functionality specified in the ADSP-TS201S data sheet(s) and the Hardware Reference book(s).

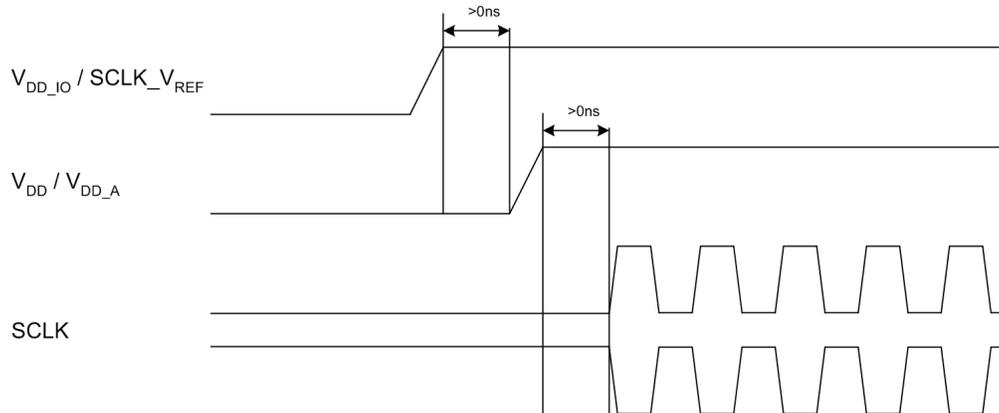
46. 03000373 - PLL Failure to Lock at Power-Up:**DESCRIPTION:**

The PLL may fail to lock correctly to the SCLK input during power-up.

V_{DD}/V_{DD_a} must be held low until after V_{DD_io} and SCLK_V_{REF} are stable and within specification. Additionally, SCLK must be held high or low until after V_{DD}/V_{DD_a} is stable and within specification. The following figure illustrates the workaround:
