Silicon Anomaly List
ADSP-BF522/BF524/BF526(C)
ABOUT ADSP-BF522/BF524/BF526(C) SILICON ANOMALIES

These anomalies represent the currently known differences between revisions of the Blackfin ADSP-BF522/BF524/BF526(C) product(s) and the functionality specified in the ADSP-BF522/BF524/BF526(C) data sheet(s) and the Hardware Reference book(s).

NR003768C

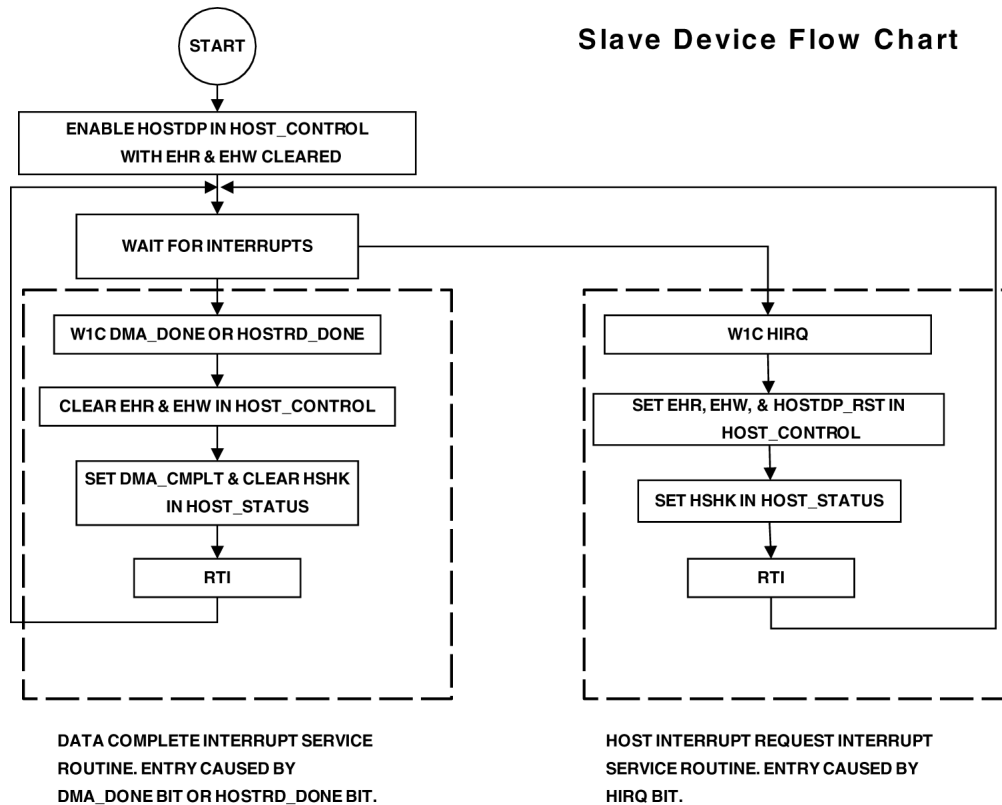
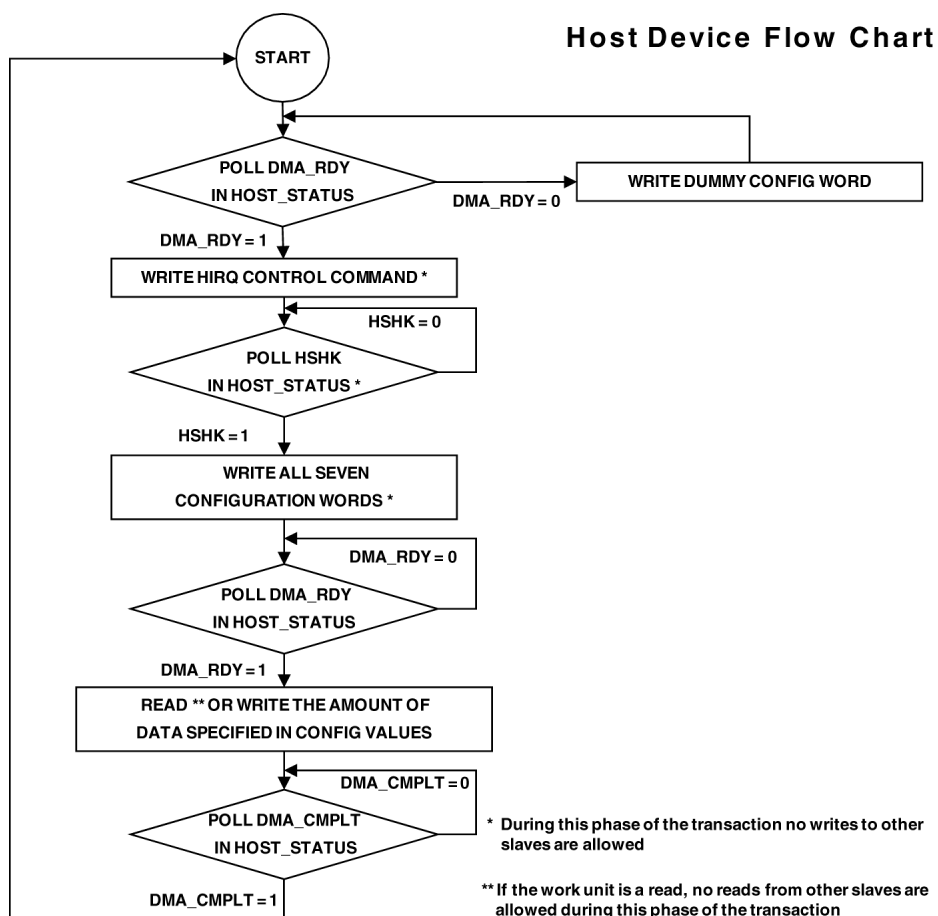
The Host DMA Port (HOSTDP) responds to certain bus activity even without the assertion of its chip enable, $\overline{\text{HOST_CE}}$. If the HOSTDP is the only slave on the bus (meaning that $\overline{\text{HOST_WR}}$ and $\overline{\text{HOST_RD}}$ are asserted by the host only for communicating with the HOSTDP), this anomaly will not be observed. There are two states in which the HOSTDP responds to bus activity (assertion of $\overline{\text{HOST_WR}}$ or $\overline{\text{HOST_RD}}$) without $\overline{\text{HOST_CE}}$ being asserted:

1. HOSTDP is Enabled and Waiting for the Host to Configure - While waiting for configuration in both acknowledge and interrupt modes, assertions of $\overline{\text{HOST_WR}}$ for other slaves can cause the HOSTDP to be erroneously configured.
2. HOSTDP is Configured for Data Reads - While waiting for data reads in both acknowledge and interrupt modes, assertions of $\overline{\text{HOST_RD}}$ for other slaves can cause the HOSTDP to subsequently return data out of order.

The following workarounds can be used for state #1:

- a. Add additional logic - Connect to $\overline{\text{HOST_WR}}$ through a 2-input OR gate where one input of the OR gate is the host's write signal and the other is the host's chip select.
- b. Time bus accesses by the host processor - Do not write to other slaves on the bus between the time that the HOSTDP is enabled and the DMA_RDY bit in HOST_STATUS is set.
- c. Change the software on both the host and the slave as shown in the following flowcharts:
