Silicon Anomaly List

ADSP-21369

NR003114F

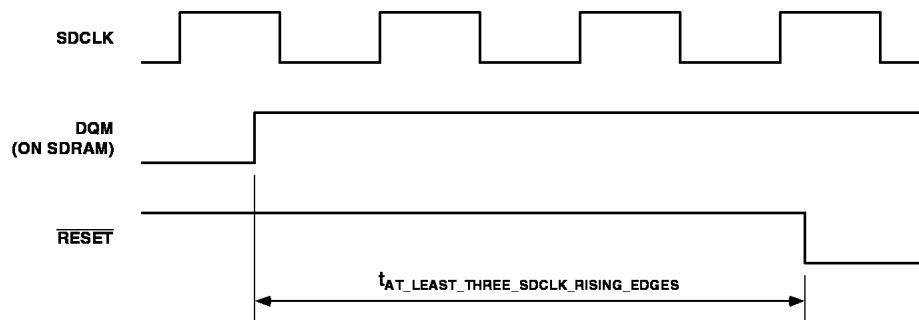
11. 08000024 - Parallel EPROM/FLASH boot following a Hard (Hot) Reset may fail if issued in the middle of external SDRAM reads:

If the SHARC processor is in the process of fetching data from external SDRAM memory, initiating a Hard (hot) reset during this process may cause the SDRAM device to continue to drive the data bus during the entire duration of /RESET being asserted, and also failing to relinquish the external data bus even when the DSP comes out of /RESET.

If the DSP had been configured to boot via parallel external FLASH or EPROM (which shares part of the same data bus with the external SDRAM), the resulting bus contention on the external data bus between the DSP trying to boot from the FLASH memory and the SDRAM continuing to drive the data bus causes incorrect boot data to be loaded in, and the booting operation fails. Once the above state is hit, subsequent DSP Resets will not correct the situation. A power-cycling sequence is required to recover from this state.

Providing an external delay of at least 3 SDCLK clock cycles between the SDRAM's DQM signal and the /RESET_IN to the DSP will also cause the problem to be avoided (see attached Figure).
