ABOUT ADSP-21364 SILICON ANOMALIES

These anomalies represent the currently known differences between revisions of the SHARC® ADSP-21364 product(s) and the functionality specified in the ADSP-21364 data sheet(s) and the Hardware Reference book(s).

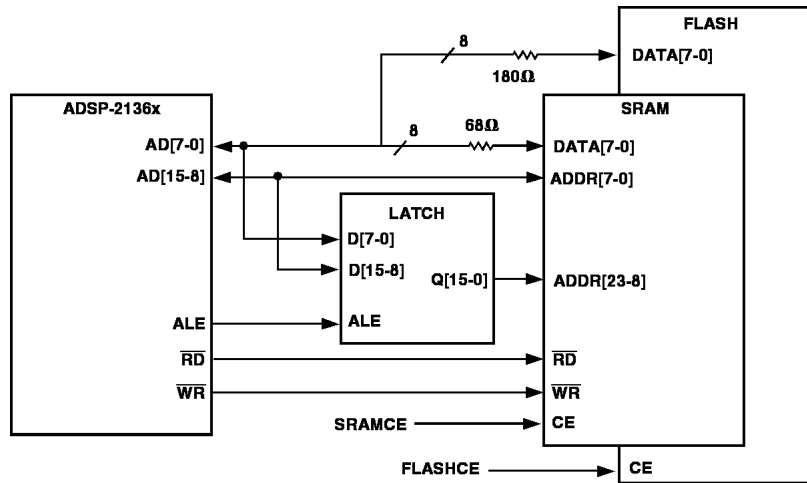
Memory Read—Parallel Port 8-Bit:

A bus contention issue has been identified on the ADSP-2136x processor's Parallel Port. When crossing an external memory address page while using DMA-READ transfers, an ALE cycle is inserted to update the upper address bits held by the external latch. When the Parallel Port transitions from a Read-cycle to an ALE cycle, insufficient time was provided to allow the external SRAM or FLASH to tri-state its bus. The bus tri-state from /OE de-assertion timing is typically longer for Flash than for SRAM devices, this necessitates a separate examination for both the SRAM and FLASH cases.

A typical 8ns SRAM will require 5-7ns to tri-state from /OE de-assertion. The ADSP-2136x only provides for approximately 4.0 ns; therefore, a 3.0ns contention possibility exists. At this time the recommended work-around is to place series resistors before the SRAM data lines, as shown in the diagram below. This resistor will limit the maximum pin current to about 22mA, while still providing sufficiently fast rise-fall rates to meet timing requirements. Our recommendation is 68-Ohms. This option will operate at full speed and require no software changes.
