Real-World Charged Board Model (CBM) Failures

Analog Devices, Inc.

Abstract – ICs that are robust to ESD at the component-level may be damaged by ESD at the board-level. Two case studies show that real-world Charged Board Model (CBM) ESD damage is typically more severe than HBM or CDM damage. Consequently, CBM damage can be easily mistaken for EOS damage. A high-capacitance yet compact PCB evaluation board facilitates qualitative CBM testing using conventional CDM test systems. Based on the case studies and CBM test results, guidelines are provided on how to minimize the likelihood of real-world CBM failures.

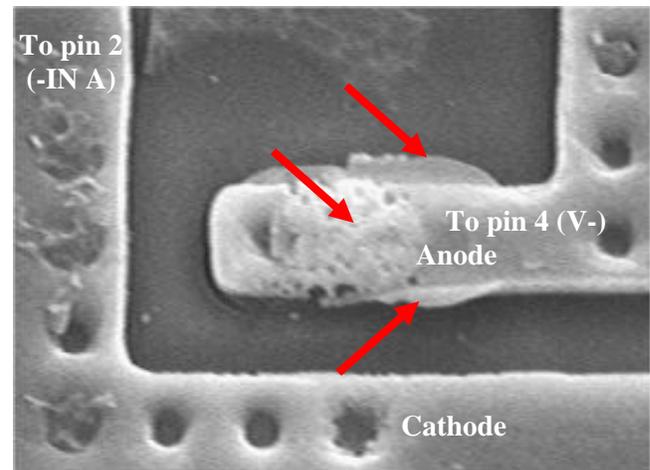
FA of the Dual Op Amp board failures consistently revealed emission sites at the anode of the input EOS/ESD protection diode between pins 2 and 4. Subsequent de-processing showed that these emission sites were due to silicon damage and melted /

reflowed AlCu that shorted this protection diode (see Figure 1).

Neither Human Body Model (HBM) nor Field-Induced Charged Device Model (FICDM) testing was able to replicate the relatively severe damage seen on the customer board failures. At the component-level, this Dual Op Amp in an 8-lead SOIC is robust to ESD events, passing at least 2000V HBM and 1000V FICDM testing to ESDA standards. Testing at 3000V HBM or 1500V FICDM caused the bias current at the input pins to exceed the 50 pA maximum specification, but the Dual Op Amp samples remained fully functional. Not surprisingly, the damage at the EOS/ESD protection diodes on the high-voltage HBM & FICDM samples was much more subtle than that shown in Figure 1; i.e., the AlCu did not melt / reflow.

Figure 1: Scanning Electron Microscope (SEM) image of the melted / reflowed AlCu (see arrows) at the anode of the input protection diode on a customer Dual Op Amp board failure. Note: The sample was deprocessed to the METAL1 layer.

Investigation of the customer's board assembly process showed that a plastic CPU socket immediately adjacent to Dual Op Amp Position #5 (the failing position) was charged to as high as 1400V prior to infrared (IR) solder reflow. This induced a relatively large charge on adjacent board components, including the Dual Op Amp. Subsequent IR reflow caused these components to discharge, resulting in the CBM damage shown in Figure 1. As corrective action, the customer added an ionizer to their production line between the automatic component insertion and IR reflow process steps to safely dissipate charges on the PCB. No ESD-related Dual Op Amp failures have occurred subsequently, thus proving the effectiveness of this corrective action.

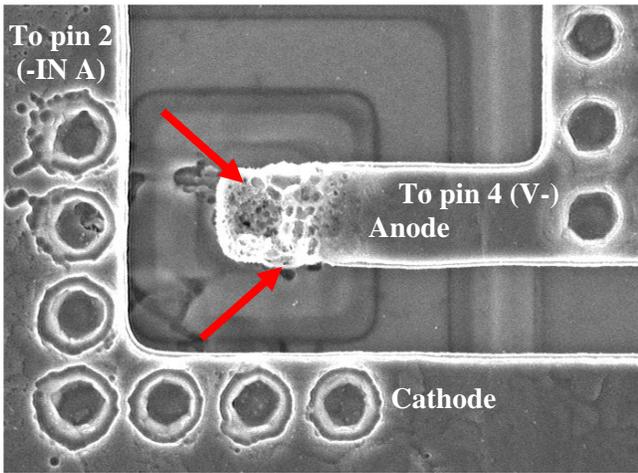
For three samples that were FICBM tested as per the previous section (III.A.3), no degradation occurred to the Dual Op Amps after $\pm 250\text{V}$ stressing but leakage was detected between pads 2 (-IN A) and 4 (V-) after -375V stressing. On three new samples that were FICBM tested at $\pm 500\text{V}$, a resistive short of $<100\Omega$ occurred between pads 2 and 4 after -500V stressing. FA of the -500V FICBM failures consistently revealed emission sites at the anode of the input EOS/ESD protection diode between pins 2 and 4. Subsequent de-processing revealed silicon damage and melted / reflowed AlCu at this protection diode (see Figure 3). Thus, FICBM testing at -500V successfully replicated the failure mode and failure mechanism observed on the real-world board failures (reference Figure 1). CBM stressing of fresh samples at higher voltages resulted in severe damage that could easily be mistaken for EOS damage. Figure 4 shows the catastrophic damage at the input EOS/ESD protection diode after -625V FICBM stressing. For negative charge voltage magnitudes of 625V and above, the AlCu anode interconnect was completely fused open.

Figure 3: SEM image of the melted / reflowed AlCu (see arrows) at the anode of the input protection diode on a Dual Op Amp that was stressed on an Evaluation Board at -500V FICBM. Note: The sample was deprocessed to the METAL1 layer.

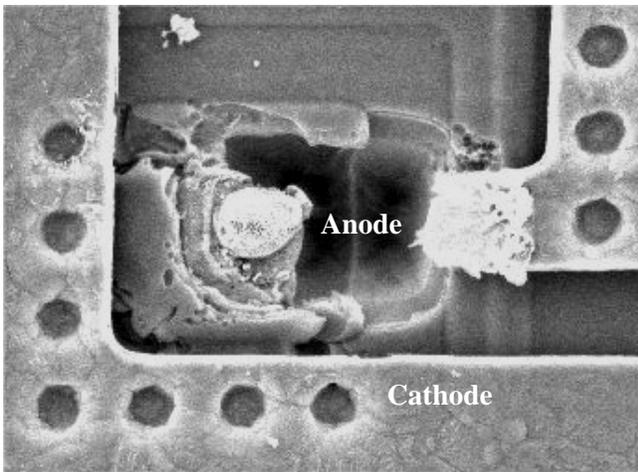
Figure 4: SEM image of the catastrophic damage (fused open AlCu and melted Si) at the same site as shown in Figures 1 and 3. This sample was stressed on an Evaluation Board at -625V FICBM. Note: The sample was deprocessed to the METAL1 layer.

3. Due to the high energy associated with real-world CBM discharges, CBM ESD damage can be far more severe than typical device-level ESD damage. Consequently, CBM ESD damage can be easily mistaken for EOS damage. For example, Figures 4 and 10 show CBM damage that might incorrectly be attributed to EOS damage.

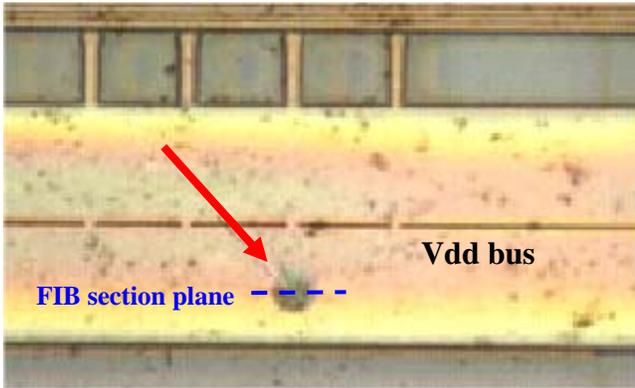
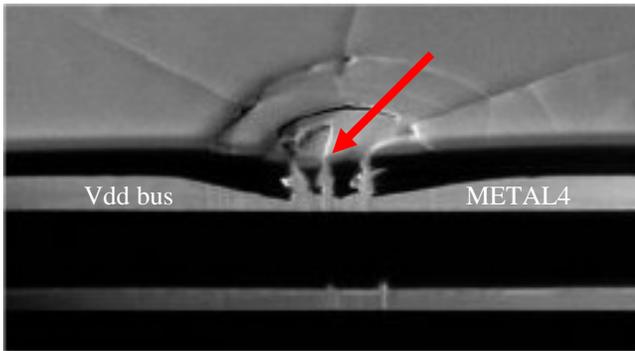
FA of samples of the DSP board failures revealed damage at Vdd buses in the form of $\sim 10 \mu m$ diameter circular areas of melted / reflowed AlCu with cracked / ruptured overlying passivation (Figures 7a & 7b). Banerjee *et al.* [15] have attributed damage similar to that in Figures 7a & 7b to extreme current densities (typically $\sim 5 \times 10^7 A/cm^2$ for AlCu METAL4) during short pulses ($\sim 100 ns$) such as ESD that heat AlCu to $\sim 1000^\circ C$, well above its melting point. At this temperature, the thermo-mechanical stress exceeds the fracture strength of the overlying oxide-nitride passivation layer, causing it to rupture. As shown in Figure 7b, the passivation ruptured in a spider-web-like pattern, and parts of the passivation "caved-in" as the AlCu metal melted and reflowed as vertical "fingers." However, the damage shown in Figures 7a & 7b did not result in the observed electrical failure modes since the Vdd buses were not fused open.

Figures 7a & 7b: Optical (upper photo) and corresponding Focused Ion Beam (FIB) cross-section image (lower photo) of the melted / reflowed METAL4 AlCu “fingers” (see arrow) and overlying cracked glassivation on a customer DSP board failure.

Further FA of the DSPs that failed in customer PCBs showed that the functional failures were due to CMOS transistor “stuck at” faults caused by excessive trapped negative charges in the gate oxide of one or more CMOS transistors. This was validated by using a Focused Ion Beam (FIB) to scan the gate oxide of stuck transistors with gallium ions (Ga^+). These positive ions neutralized the negative trapped charges, resulting in full recovery of the failing transistors. The charge trap sites were generated when the $\sim 12\text{V}$ tunneling voltage of the gate oxides of these transistors was exceeded. This occurred when the product of the Vdd interconnect resistance for these transistors ($R_{\text{INTERCONNECT}}$) and the high current ESD transients (I_{PEAK}) in these Vdd interconnects was $>12\text{V}$. Depending on the density of the trap sites generated in the gate oxide and their fill rate during subsequent PCB operation, the DSP time-to-failure ranged from days to months after the ESD events.

Investigation of the customer's board assembly process showed that the DSP on the PCB was sometimes charged to at least $\pm 300\text{V}$ prior to wave soldering. Much of this charging was caused by the prior manufacturing step in which large plastic edge connectors were attached, resulting in inductive charging of the PCBs. Subsequent wave soldering instantaneously discharged the DSP and all other components on the PCB. As corrective action, the customer added an ionizer to their production line just prior to wave soldering to safely dissipate charges on the PCB. No ESD-related DSP failures have occurred subsequently, thus proving the effectiveness of this corrective action.

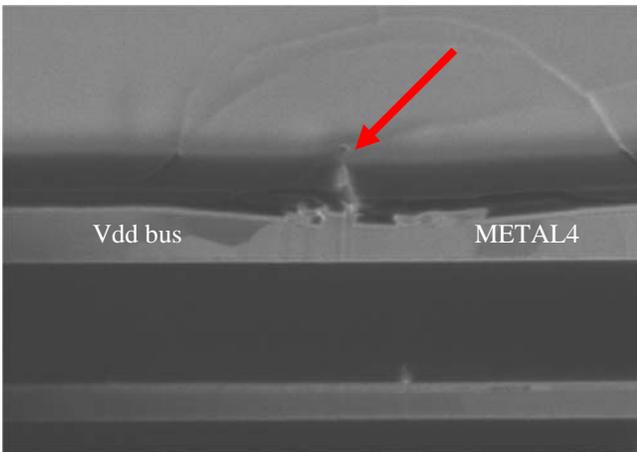
For three PCBs that were CBM tested as per the previous section (III.B.3), the DSPs showed Vdd bus damage similar to that in Figure 7a after -250V stressing. FIB analysis of these CBM failures consistently showed ~10 μm diameter circular areas of melted / reflowed AlCu with cracked / ruptured overlying passivation (see Figure 9). Thus, FICBM testing successfully replicated the real-world board failures (reference Figure 7b).

Figure 9: FIB cross-section image of the melted / reflowed MET4 AlCu (see arrow) and cracked glassivation on a DSP IC stressed at -250V CBM using the setup in Figure 8.

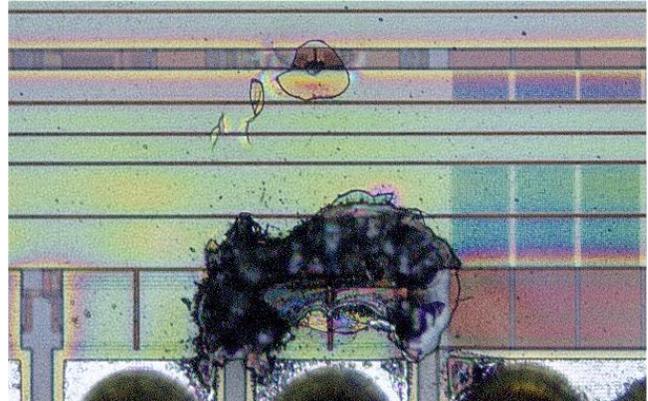
Figure 10: Typical catastrophic DSP damage observed along the supply buses and adjacent bond pads after stressing the cut-down customer boards at the CBM fail voltages listed in Table 2. Note the large areas of melted / reflowed AlCu and missing passivation above this damage.
