ABOUT ADSP-21161N SILICON ANOMALIES

These anomalies represent the currently known differences between revisions of the SHARC ADSP-21161N product(s) and the functionality specified in the ADSP-21161N data sheet(s) and the Hardware Reference book(s).

NR002446P

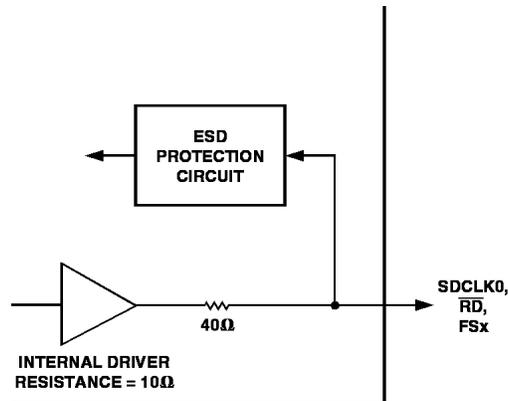
5. 04000005 - FS0, FS1, FS2, FS3, \overline{RD} , and SDCLK0 ESD protection feedback paths are missing impedance-matching resistors:

The FS0, FS1, FS2, FS3, \overline{RD} , and SDCLK0 pins include an internal ESD protection circuit feedback path which does not contain a serial terminating resistor. Depending on the trace-length to other devices, serial transfers and memory accesses may fail because of transmission line reflections in the traces. The following diagram illustrates the internal driver implementation of these pins with the unterminated ESD protection feedback path:

Because of the unterminated feedback path, there is a potential for a failure in serial transfers to transmit incorrect data or latch received data correctly in the serial ports.
