## ABOUT ADSP-21261 SILICON ANOMALIES

These anomalies represent the currently known differences between revisions of the SHARC ADSP-21261 product(s) and the functionality specified in the ADSP-21261 data sheet(s) and the Hardware Reference book(s).

#### NR002914J

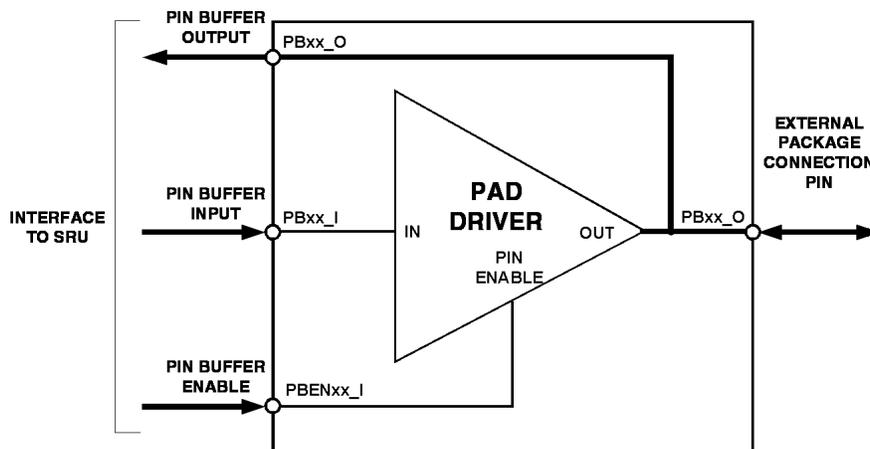
There is some sensitivity to noise on the RD\_B, SPORTx\_CLK, and SPORTx\_FS signals of the ADSP-2126x processors. This has the potential to cause errors during parallel port read operations including booting, and sport issues when the sport is driving the sport clock & frame sync and an external device is driving the data. (The SPORT signals are routed through the signal routing unit (SRU) to the DAI\_P[20:1] pins.)

1. In certain cases, by programming the SRU CLK and FS registers, the reflection sensitivity issue in these signals can be avoided. Consider this Sport Clock example: (The Frame Sync configuration is analogous) In its default routing, the SRU maps the signal from the DAI pin (PBxx\_O) back to the Sport Clock Input (SPORTxCLK\_I), as well as routing the sport clk output (SPORTxCLK\_O) to the Pin Buffer Input (PBxx\_I). This connection of PBxx\_O to SPORTxCLK\_I opens a vulnerability to a glitch coming in even though the Sport is driving the clock as an output.

By programming the Signal Routing Unit (SRU) to remove this input path, we can avoid this vulnerability.

In the figure, by default SPORTxCLK\_I would be connected to PBxx\_O and SPORTxCLK\_O would be routed to PBxx\_I. The workaround is to leave the routing of SPORTCLKx\_I to PBxx\_I as before, providing the sport clock off-chip, but also routing it directly back to SPORTCLKx\_I to give the state machine it's signal. This effectively closes off the external access to SPORTCLK\_I. For more information about the SRU, consult the DAI Chapter of the ADSP-2126x Hardware Reference Manual.

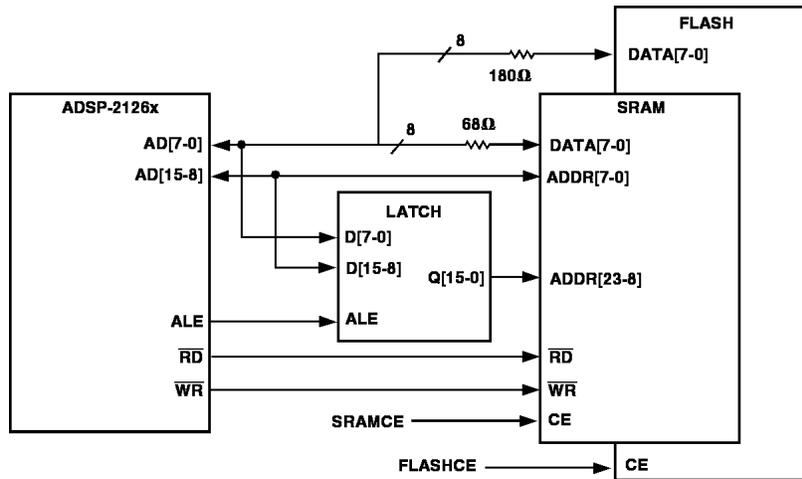
#### Memory Read—Parallel Port 8-Bit:

A bus contention issue has been identified on the ADSP-2126x Parallel Port. When crossing an external memory address page while using DMA-READ transfers, an ALE cycle is inserted to update the upper address bits held by the external latch. When the Parallel Port transitions from a Read-cycle to an ALE cycle, insufficient time was provided to allow the external SRAM or FLASH to tri-state its bus. The bus tri-state from /OE de-assertion timing is typically longer for Flash than for SRAM devices, this necessitates a separate examination for both the SRAM and FLASH cases. (Timing information assumes a 200 MHz core clock rate)

A typical 8ns SRAM will require 5-7ns to tri-state from /OE de-assertion. The ADSP-2126x only provides for approximately 4.0 ns; therefore, a 3.0ns contention possibility exists. At this time the recommended work-around is to place series resistors before the SRAM data lines, as shown in the diagram below. This resistor will limit the maximum pin current to about 22mA, while still providing sufficiently fast rise-fall rates to meet timing requirements. Our recommendation is 68-Ohms. This option will operate at full speed and require no software changes.
