ABOUT ADSP-21262 SILICON ANOMALIES

NR002744K

SUMMARY OF SILICON ANOMALIES

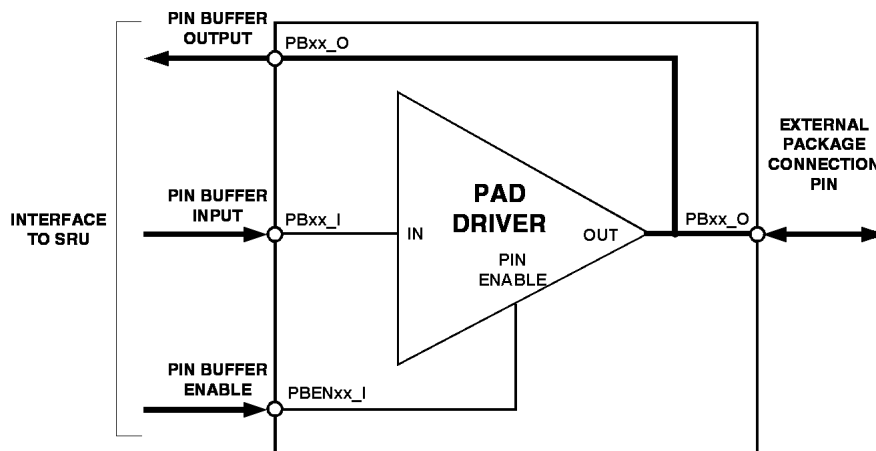
There is some sensitivity to noise on the RD_B, SPORTx_CLK, and SPORTx_FS signals of the ADSP-2126x processors. This has the potential to cause errors during parallel port read operations including booting, and sport issues when the sport is driving the sport clock & frame sync and an external device is driving the data. (The SPORT signals are routed through the signal routing unit (SRU) to the DAI_P[20:1] pins.)

1. In certain cases, by programming the SRU CLK and FS registers, the reflection sensitivity issue in these signals can be avoided. Consider this Sport Clock example: (The Frame Sync configuration is analogous) In its default routing, the SRU maps the signal from the DAI pin (PBxx_O) back to the Sport Clock Input (SPORTxCLK_I), as well as routing the sport clk output (SPORTxCLK_O) to the Pin Buffer Input (PBxx_I). This connection of PBxx_O to SPORTxCLK_I opens a vulnerability to a glitch coming in even though the Sport is driving the clock as an output.

By programming the Signal Routing Unit (SRU) to remove this input path, we can avoid this vulnerability.

In the figure, by default SPORTxCLK_I would be connected to PBxx_O and SPORTxCLK_O would be routed to PBxx_I. The workaround is to leave the routing of SPORTCLKx_I to PBxx_I as before, providing the sport clock off-chip, but also routing it directly back to SPORTCLKx_I to give the state machine its signal. This effectively closes off the external access to SPORTCLK_I. For more information about the SRU, consult the DAI Chapter of the ADSP-2126x Hardware Reference Manual.

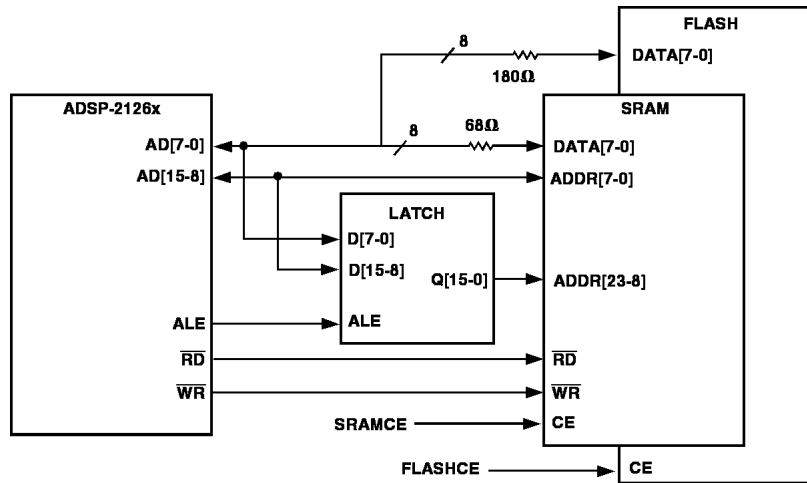
Memory Read—Parallel Port 8-Bit:

A bus contention issue has been identified on the ADSP-2126x Parallel Port. When crossing an external memory address page while using DMA-READ transfers, an ALE cycle is inserted to update the upper address bits held by the external latch. When the Parallel Port transitions from a Read-cycle to an ALE cycle, insufficient time was provided to allow the external SRAM or FLASH to tri-state its bus. The bus tri-state from /OE de-assertion timing is typically longer for Flash than for SRAM devices, this necessitates a separate examination for both the SRAM and FLASH cases. (Timing information assumes a 200 MHz core clock rate)

A typical 8ns SRAM will require 5-7ns to tri-state from /OE de-assertion. The ADSP-2126x only provides for approximately 4.0 ns; therefore, a 3.0ns contention possibility exists. At this time the recommended work-around is to place series resistors before the SRAM data lines, as shown in the diagram below. This resistor will limit the maximum pin current to about 22mA, while still providing sufficiently fast rise-fall rates to meet timing requirements. Our recommendation is 68-Ohms. This option will operate at full speed and require no software changes.
