SHARC Processor

Silicon Anomaly List

ADSP-21362

ABOUT ADSP-21362 SILICON ANOMALIES

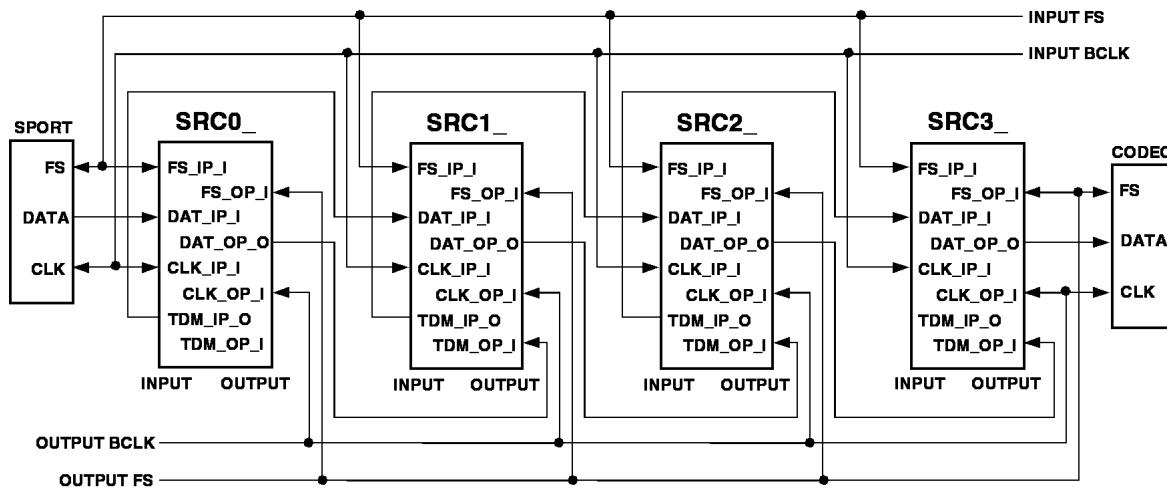
In the TDM Daisy chaining mode the ASRCs can be connected as follows to achieve TDM mode:

When the ASRCs are used in TDM Daisy chaining mode, the MSB of the input data is lost at the output of each ASRC in the chain. This anomaly is applicable for the TDM mode in both the bypass and non-bypass modes. The following example provides the expected failure pattern for the bypass mode, since in bypass mode the incoming data is not modified by the ASRC.

For a TDM daisy chain with 8 channels in BYPASS mode, the output of the final ASRC in the chain will result in three-bit left shift for the channels 1 and 2, two bit left shift for the channels 3 and 4 and one bit left shift for the channels 5 and 6. The channels 7 and 8 will not have any data shift. At the output end, three MSBs will be lost for the channels 1 and 2, two MSBs will be lost for the channels 3 and 4 and one MSB will be lost for the channels 5 and 6.

For a TDM daisy chain in NON-BYPASS mode, the output of the TDM Daisy chain will be corrupted completely because of the MSB bit loss in each ASRC in the chain.

The workaround for this anomaly must be carried out in the software, only on the input data to the ASRCs in TDM daisy chaining mode. It can not be implemented on the output data from the ASRCs. The workaround implementation in the software adds some core MIPS to the application. For the devices like ADC/CODECs the workaround may not be implemented directly. For such systems, two serial ports of the processor should be dedicated for this purpose. One serial port should be used for receiving the data from the ADC/CODEC and the other one should be used for transmitting the modified input data to the ASRC.

When the ASRCs are used in TDM daisy chaining mode, only the 24-MSBs of the input 32-bit data is used and the 8-LSBs are not used by the ASRC. The anomaly can be workaround by shifting the 24-MSBs of the data to the 8-LSBs as follows:

1. Right shift the input data for channels 1 and 2 by three bits. Now the 24-MSBs which has the data are placed in the bits from 28 - 5.
2. Right shift the input data for channels 3 and 4 by two bits. Now the 24-MSBs which has the data are placed in the bits from 29 - 6.
3. Right shift the input data for channels 5 and 6 by one bit. Now the 24-MSBs which has the data are placed in the bits from 30 - 7.
4. The input data for channels 7 and 8 need not be modified.
