ABOUT ADSP-21364 SILICON ANOMALIES

These anomalies represent the currently known differences between revisions of the SHARC® ADSP-21364 product(s) and the functionality specified in the ADSP-21364 data sheet(s) and the Hardware Reference book(s).

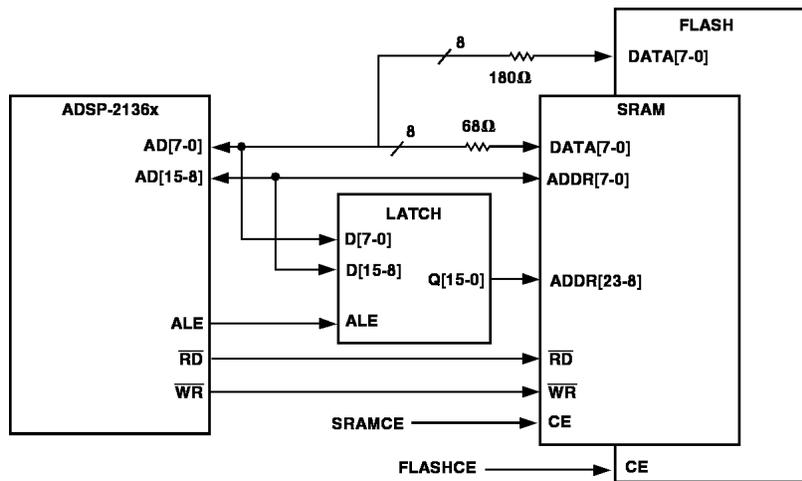
Memory Read—Parallel Port 8-Bit:

A typical 8ns SRAM will require 5-7ns to tri-state from /OE de-assertion. The ADSP-2136x only provides for approximately 4.0 ns; therefore, a 3.0ns contention possibility exists. At this time the recommended work-around is to place series resistors before the SRAM data lines, as shown in the diagram below. This resistor will limit the maximum pin current to about 22mA, while still providing sufficiently fast rise-fall rates to meet timing requirements. Our recommendation is 68-Ohms. This option will operate at full speed and require no software changes.

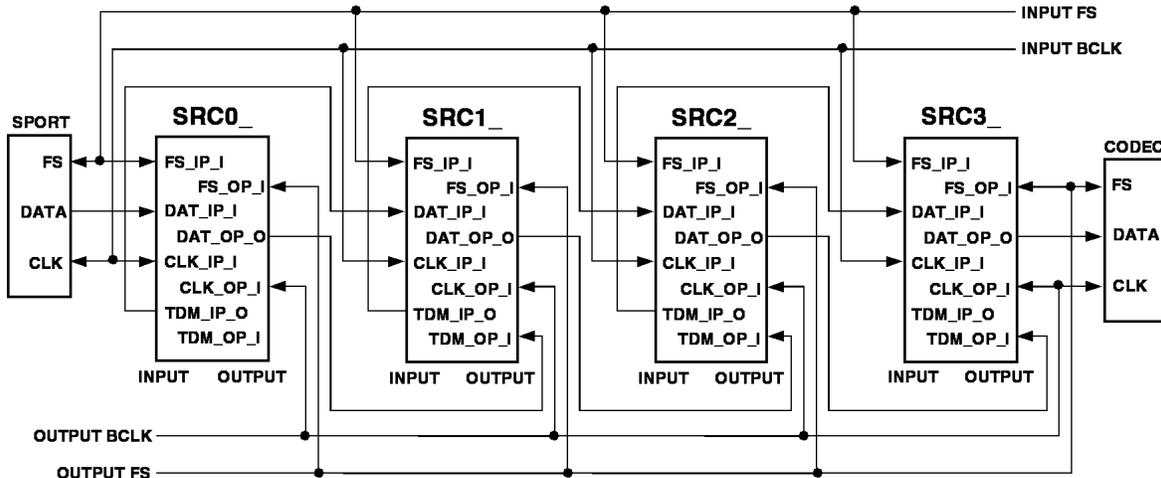
In the TDM Daisy chaining mode the ASRCs can be connected as follows to achieve TDM mode:

When the ASRCs are used in TDM Daisy chaining mode, the MSB of the input data is lost at the output of each ASRC in the chain. This anomaly is applicable for the TDM mode in both the bypass and non-bypass modes. The following example provides the expected failure pattern for the bypass mode, since in bypass mode the incoming data is not modified by the ASRC.

When the ASRCs are used in TDM daisy chaining mode, only the 24-MSBs of the input 32-bit data is used and the 8-LSBs are not used by the ASRC. The anomaly can be workaround by shifting the 24-MSBs of the data to the 8-LSBs as follows:
