ABOUT ADSP-21371/ADSP-21375 SILICON ANOMALIES

These anomalies represent the currently known differences between revisions of the SHARC® ADSP-21371/ADSP-21375 product(s) and the functionality specified in the ADSP-21371/ADSP-21375 data sheet(s) and the Hardware Reference book(s).

NR003347G

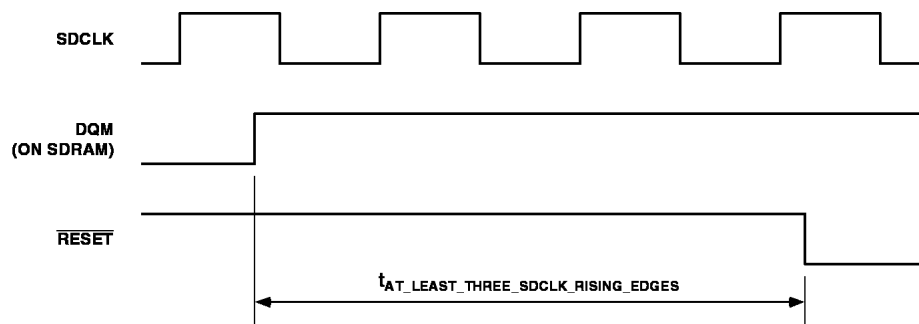
4. 09000013 - Parallel EPROM/FLASH boot following a Hard (Hot) Reset may fail if issued in the middle of external SDRAM reads:

If the processor is in the process of fetching data from external SDRAM memory, or executing code from external SDRAM memory, initiating a Hard (hot) reset during this process may cause the SDRAM device to continue to drive the data bus during the entire duration of $\overline{\text{RESET}}$ being asserted, and also failing to relinquish the external data bus even when the DSP comes out of $\overline{\text{RESET}}$.

If the DSP had been configured to boot via parallel external FLASH or EPROM (which shares part of the same data bus with the external SDRAM), the resulting bus contention on the external data bus between the DSP trying to boot from the FLASH memory and the SDRAM continuing to drive the data bus causes incorrect boot data to be loaded in, and the booting fails. Once the above state is hit, subsequent DSP Resets will not correct the situation. A power-cycling sequence is required to recover from this state.

Providing an external delay of at least 3 SDCLK clock cycles between the SDRAM's DQM signal and the $\overline{\text{RESET_IN}}$ to the DSP will also cause the problem to be avoided (see attached Figure).
