## ADSP-2199x Anomaly List for Revisions up to 1.1

Created, 18<sup>th</sup> November 2009

These anomalies represent the currently known differences between revisions of ADSP-2199x devices and the functionality specified in the ADSP-2199x data sheets and ADSP-2199x DSP Core and Peripherals Manuals. A revision number with the form "-x.x" is branded on all parts.

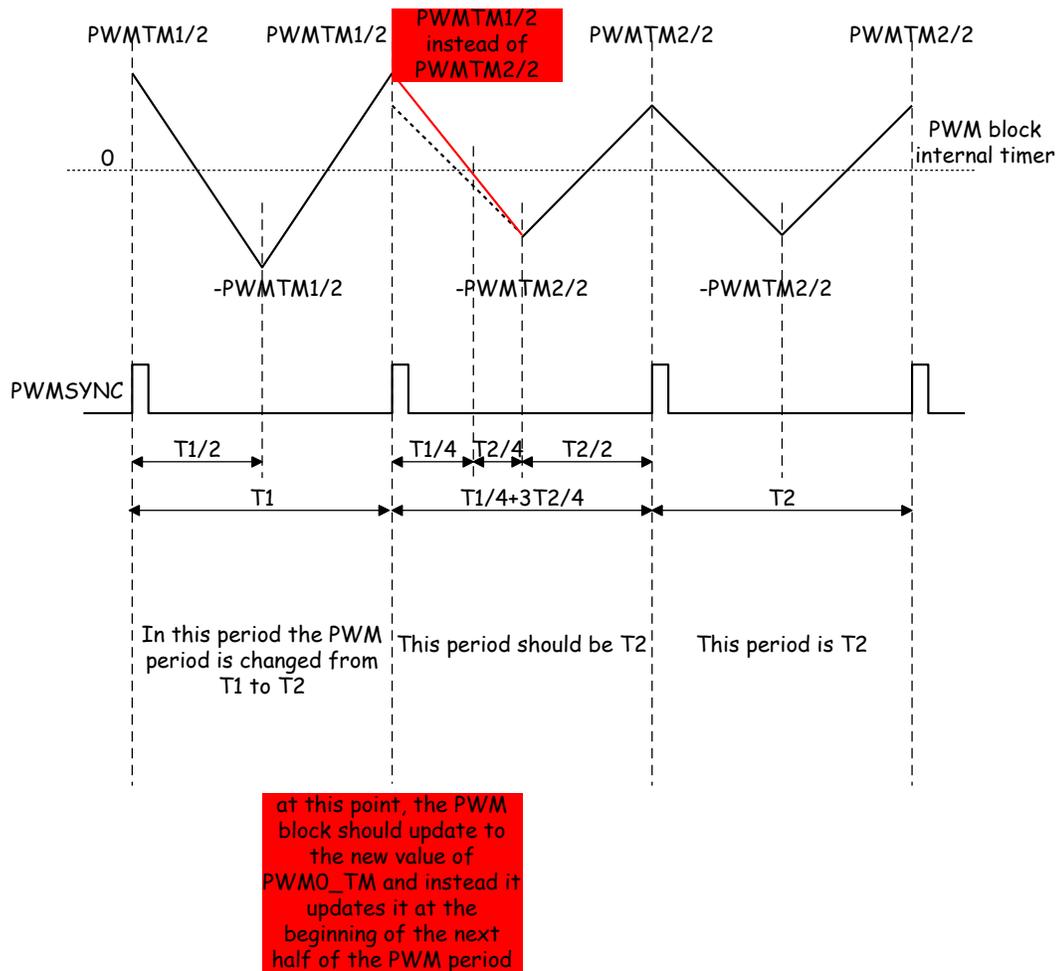
4. Real time update of PWM period

When the PWM period is changed in real time (i.e. a new value is written in the register PWM0\_TM), the first half of the new PWM period after the change is not as intended (please see figure below). After this first half, the following PWM periods have the right value. The anomaly happens in both single update and double update mode.

1. For the first PWM period after modifying PWM0\_TM register, impose the duty cycles PWMCHA, PWMCHB, PWMCHC knowing that this period is  $T1/4+3*T2/4$  (in single update mode) or  $T1/4+T2/4$  (in double update mode).
2. Disable and re-enable the PWM block. If both BIT 1 and BIT0 of PWM0\_CTRL are cleared (0 is written over) and then immediately set back to 1, the PWM block changes instantaneously to the new PWM period. The drawbacks are: the current PWM period is abruptly interrupted and a new PWM period with the new value is started; a new PWMSYNC pulse is immediately generated, i.e. a supplementary PWM interrupt is furnished; the PWM outputs are disabled for 12 CCLK periods (in case  $HCLK=CCLK/2$ ), the time to access two times the PWM0\_CTRL register.
