Silicon Anomaly List

ADSP-BF523/BF525/BF527(C)

ABOUT ADSP-BF523/BF525/BF527(C) SILICON ANOMALIES

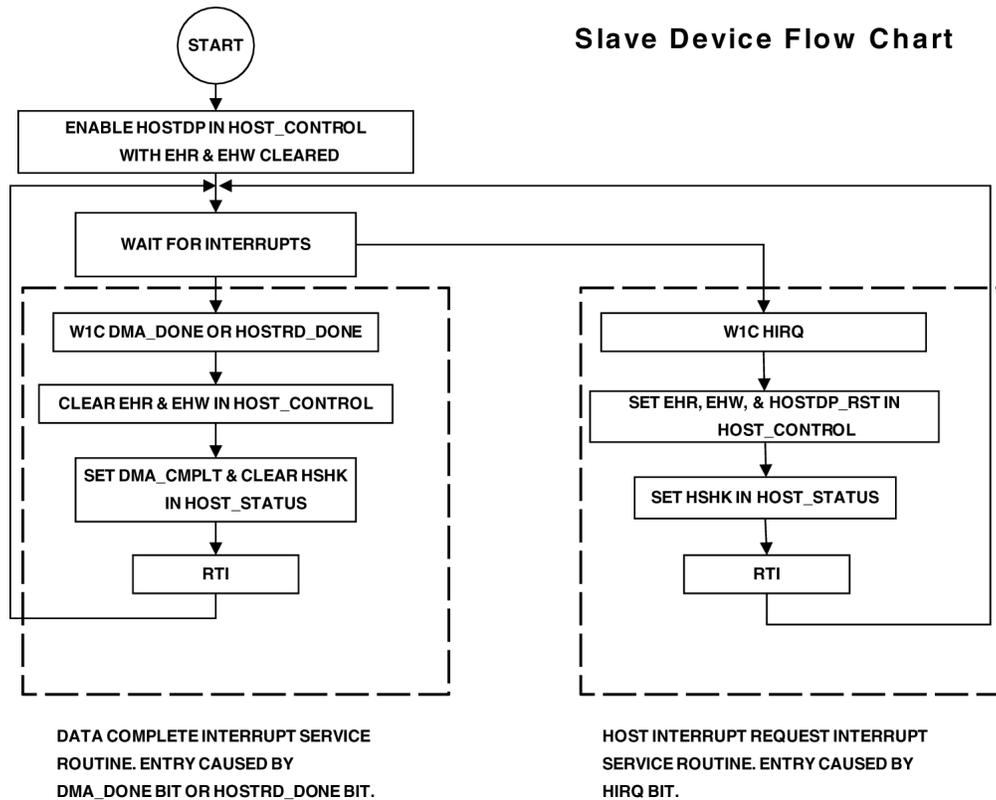
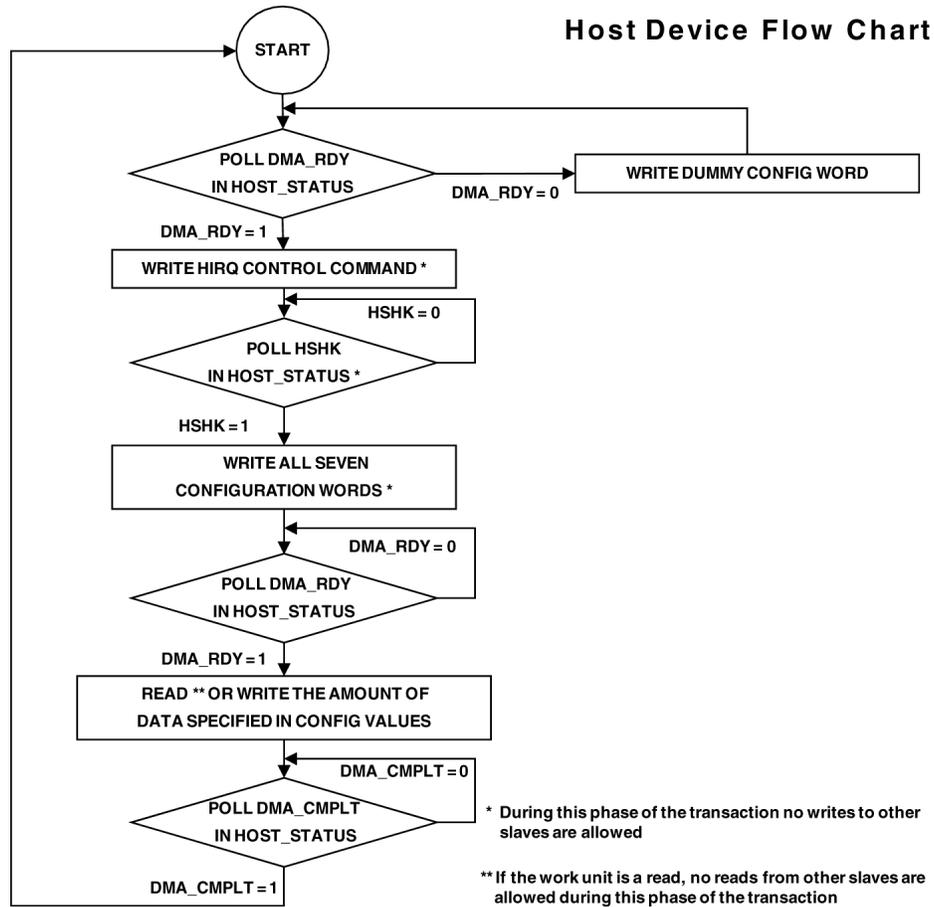
The Host DMA Port (HOSTDP) responds to certain bus activity even without the assertion of its chip enable, HOST_CE. If the HOSTDP is the only slave on the bus (meaning that HOST_WR and HOST_RD are asserted by the host only for communicating with the HOSTDP), this anomaly will not be observed. There are two states in which the HOSTDP responds to bus activity (assertion of HOST_WR or HOST_RD) without HOST_CE being asserted:

- 1) HOSTDP is Enabled and Waiting for the Host to Configure - While waiting for configuration in both acknowledge and interrupt modes, assertions of HOST_WR for other slaves can cause the HOSTDP to be erroneously configured.
- 2) HOSTDP is Configured for Data Reads - While waiting for data reads in both acknowledge and interrupt modes, assertions of HOST_RD for other slaves can cause the HOSTDP to subsequently return data out of order.

The following workarounds can be used for state #1:

- 1) Add additional logic - Connect to HOST_WR through a 2-input OR gate where one input of the OR gate is the host's write signal and the other is the host's chip select.
- 2) Time bus accesses by the host processor - Do not write to other slaves on the bus between the time that the HOSTDP is enabled and the DMA_RDY bit in HOST_STATUS is set.
- 3) Change the software on both the host and the slave as shown in the following flowcharts:
