Silicon Anomaly List

ADSP-BF531/BF532/BF533

ABOUT ADSP-BF531/BF532/BF533 SILICON ANOMALIES

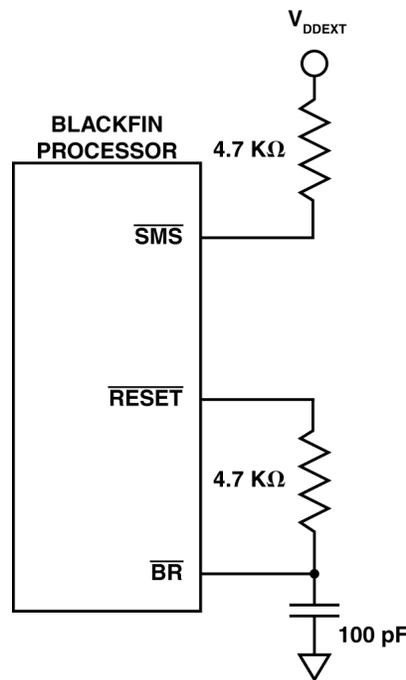
43. 05000471 - Boot Failure When SDRAM Control Signals Toggle Coming Out Of Reset:**DESCRIPTION:**

When $\overline{\text{RESET}}$ is de-asserted at the conclusion of the power-on reset sequence (not applicable to warm resets), there is a very small chance that the SDRAM control signals ($\overline{\text{SRAS}}$, $\overline{\text{SCAS}}$, $\overline{\text{SWE}}$, $\overline{\text{SMS}}$, $\overline{\text{SCKE}}$, and SA10) may be driven low for a single CLKOUT cycle. This activity can cause certain SDRAM devices to enter engineering test modes that result in the SDRAM driving data onto the shared EBIU data lines that the Blackfin processor is going to read from when configured to boot or execute from parallel flash.

When booting from parallel flash (BMODE = b#01), this contention corrupts the boot stream and causes the processor to hang. At this point, power-cycling the processor is required to clear the condition.

When executing from parallel flash (BMODE = b#00), this contention corrupts the op-codes and causes the processor to execute incorrect or illegal instructions, which may result in improper application execution or unexpected exceptions.

A hardware workaround can be implemented in the form of an RC delay circuit introduced between the $\overline{\text{RESET}}$ and bus request ($\overline{\text{BR}}$) pins:

The delayed version of $\overline{\text{RESET}}$ seen on $\overline{\text{BR}}$ causes the Blackfin processor to continue to three-state the SDRAM control signals after the rising edge of $\overline{\text{RESET}}$ for longer than one CLKOUT cycle, which over-rides the glitch behavior described by this anomaly. The pull-up resistor on the $\overline{\text{SMS}}$ pin ensures that the memory-select signal remains de-asserted while the processor is three-stating the $\overline{\text{SMS}}$ output. Additional pull-ups are needed on the $\overline{\text{AMSx}}$ signals as well. This drawing contains the local connections to the Blackfin processor only. The $\overline{\text{RESET}}$ input pin is connected to the reset supervisor circuit, and the $\overline{\text{SMS}}$ output pin connects to the SDRAM memory select pin.
