ABOUT ADSP-BF542/BF544/BF547/BF548/BF549 SILICON ANOMALIES

These anomalies represent the currently known differences between revisions of the Blackfin® ADSP-BF542/BF544/BF547/BF548/BF549 product(s) and the functionality specified in the ADSP-BF542/BF544/BF547/BF548/BF549 data sheet(s) and the Hardware Reference book(s).

SUMMARY OF SILICON ANOMALIES

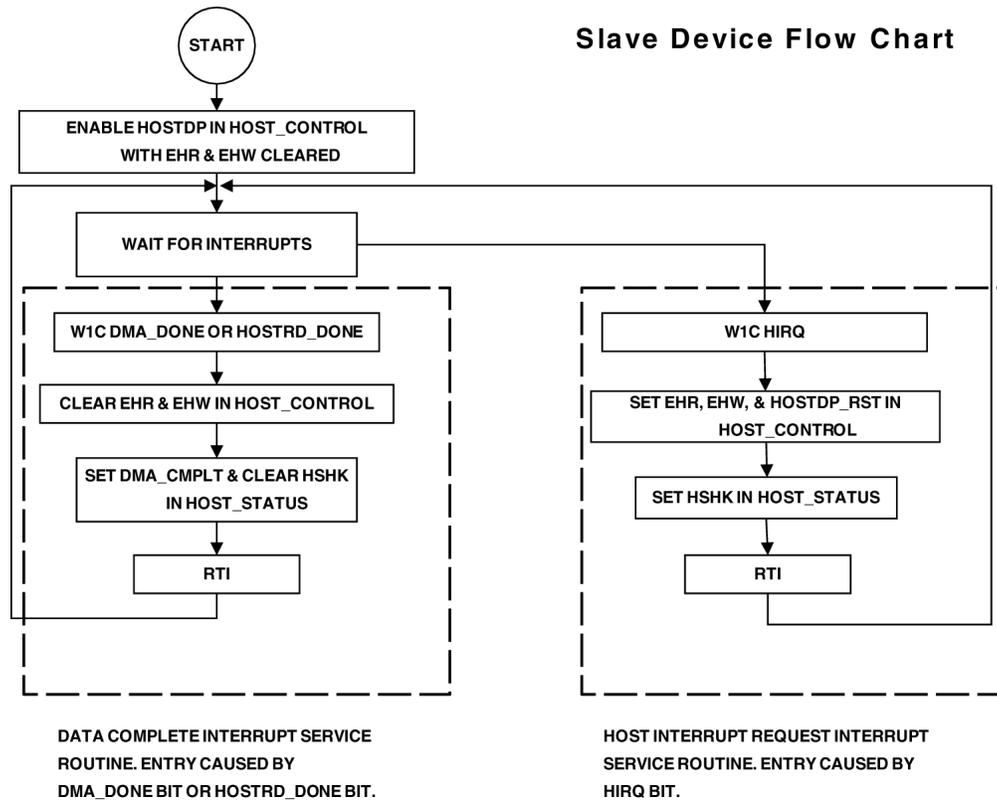
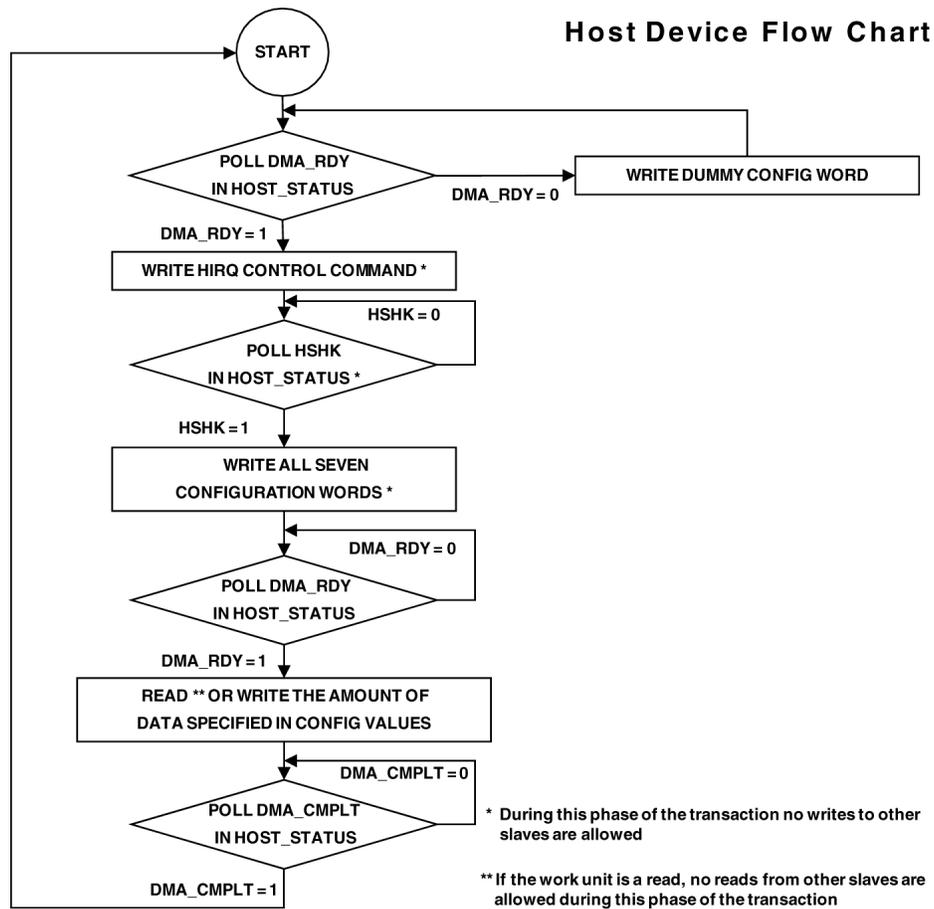
The Host DMA Port (HOSTDP) responds to certain bus activity even without the assertion of its chip enable, $\overline{\text{HOST_CE}}$. If the HOSTDP is the only slave on the bus (meaning that $\overline{\text{HOST_WR}}$ and $\overline{\text{HOST_RD}}$ are asserted by the host only for communicating with the HOSTDP), this anomaly will not be observed. There are two states in which the HOSTDP responds to bus activity (assertion of $\overline{\text{HOST_WR}}$ or $\overline{\text{HOST_RD}}$) without $\overline{\text{HOST_CE}}$ being asserted:

- 1) HOSTDP is Enabled and Waiting for the Host to Configure - While waiting for configuration in both acknowledge and interrupt modes, assertions of $\overline{\text{HOST_WR}}$ for other slaves can cause the HOSTDP to be erroneously configured.
- 2) HOSTDP is Configured for Data Reads - While waiting for data reads in both acknowledge and interrupt modes, assertions of $\overline{\text{HOST_RD}}$ for other slaves can cause the HOSTDP to subsequently return data out of order.

The following workarounds can be used for state #1:

- 1) Add additional logic - Connect to $\overline{\text{HOST_WR}}$ through a 2-input OR gate where one input of the OR gate is the host's write signal and the other is the host's chip select.
- 2) Time bus accesses by the host processor - Do not write to other slaves on the bus between the time that the HOSTDP is enabled and the DMA_RDY bit in HOST_STATUS is set.
- 3) Change the software on both the host and the slave as shown in the following flowcharts:
