ABOUT ADSP-BF542/BF544/BF547/BF548/BF549 SILICON ANOMALIES

These anomalies represent the currently known differences between revisions of the Blackfin® ADSP-BF542/BF544/BF547/BF548/BF549 product(s) and the functionality specified in the ADSP-BF542/BF544/BF547/BF548/BF549 data sheet(s) and the Hardware Reference book(s).

NR003403N

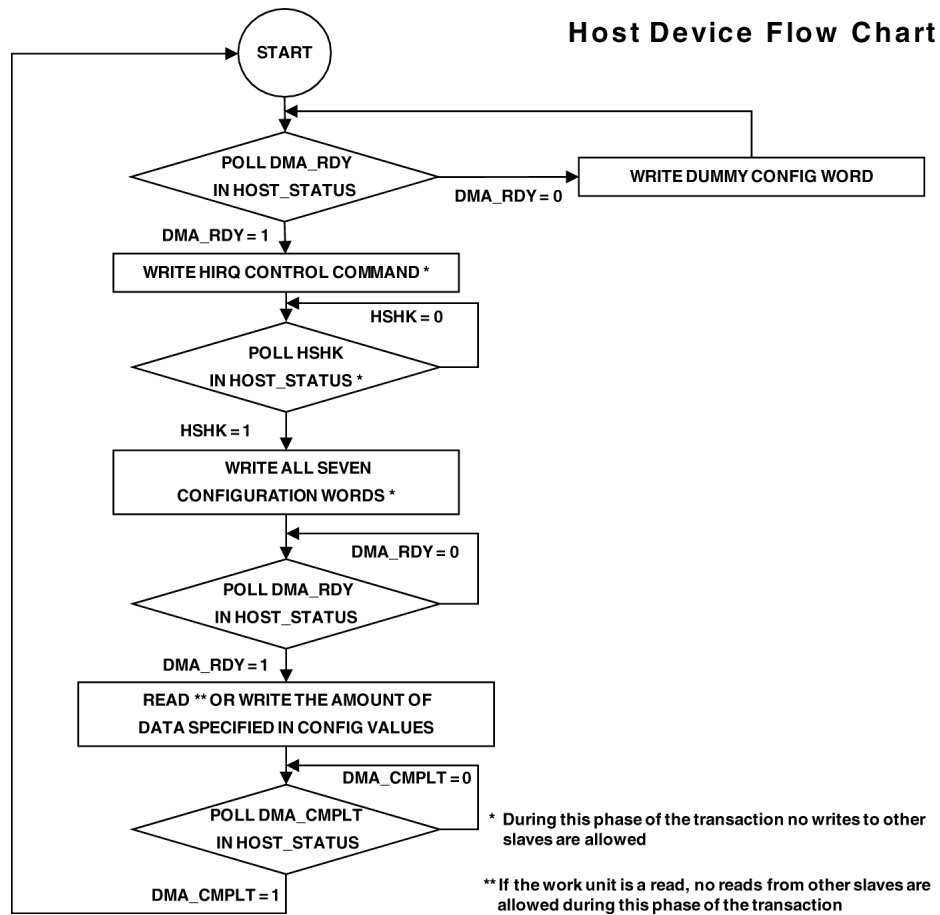
The Host DMA Port (HOSTDP) responds to certain bus activity even without the assertion of its chip enable, HOST_CE. If the HOSTDP is the only slave on the bus (meaning that HOST_WR and HOST_RD are asserted by the host only for communicating with the HOSTDP), this anomaly will not be observed. There are two states in which the HOSTDP responds to bus activity (assertion of HOST_WR or HOST_RD) without HOST_CE being asserted:

- 1) HOSTDP is Enabled and Waiting for the Host to Configure - While waiting for configuration in both acknowledge and interrupt modes, assertions of HOST_WR for other slaves can cause the HOSTDP to be erroneously configured.
- 2) HOSTDP is Configured for Data Reads - While waiting for data reads in both acknowledge and interrupt modes, assertions of HOST_RD for other slaves can cause the HOSTDP to subsequently return data out of order.

The following workarounds can be used for state #1:

- 1) Add additional logic - Connect to HOST_WR through a 2-input OR gate where one input of the OR gate is the host's write signal and the other is the host's chip select.
- 2) Time bus accesses by the host processor - Do not write to other slaves on the bus between the time that the HOSTDP is enabled and the DMA_RDY bit in HOST_STATUS is set.
- 3) Change the software on both the host and the slave as shown in the following flowcharts:
