# Mixed-Signal Control Processor with ARM Cortex-M4 and 16-Bit ADCs

## Silicon Anomaly List

## ADSP-CM402F/CM403F/CM407F/CM408F/CM409F

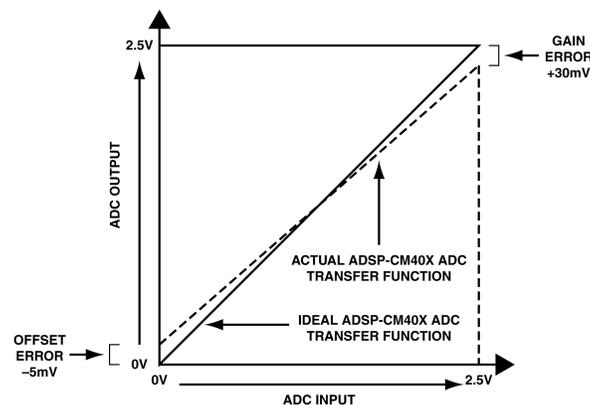
### 18. 17000023 - Offset Error and Gain Error of the ADCs deviate from the specification:

The two 16-bit ADCs have a higher than specified Offset Error and Gain Error. An Offset Error of upto -5mV (typical) and a Gain Error of +30mV (typical) has been measured. This will be different for each part and each ADC. There is no reduction in the ADC input signal range (0V - 2.5V) due to these errors. The user has to do a one-time measurement of these errors and include a correction factor in their software.

A pictorial description of the Errors is shown below.

None
