Mixed-Signal Control Processor with ARM Cortex-M4/M0 and 16-Bit ADCs

Silicon Anomaly List

ADSP-CM411F/412F/413F/416F/417F/418F/419F

NR004483D

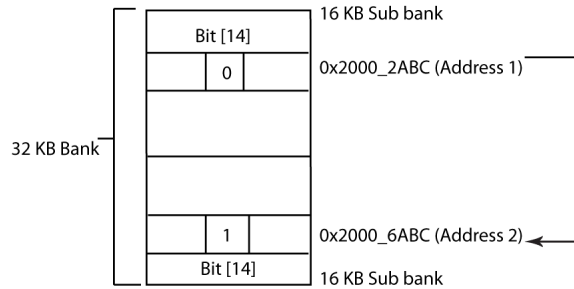
19. 17000064 - Back-to-back Writes to Internal SRAM May Be Lost:

When back-to-back writes are performed to the same 32 KB bank of the internal SRAM, the first write may be lost if address bit 14 is different (all other bits are the same) on the second write.

The figure shows an example where address bit 14 is different for two accesses.

The following workarounds utilize memory placement strategies, where two consecutive write addresses are not 16 KB apart.

For core-based accesses, the anomaly can occur on adjacent writes on the same bus between a local and global variable with addresses 16 KB apart and in the same bank.

In this case, the workaround is to use linker segments for code and variables to segregate them in a single 16 KB bank. If the total size is greater than 16 KB, place the variables in a separate 32 KB bank.

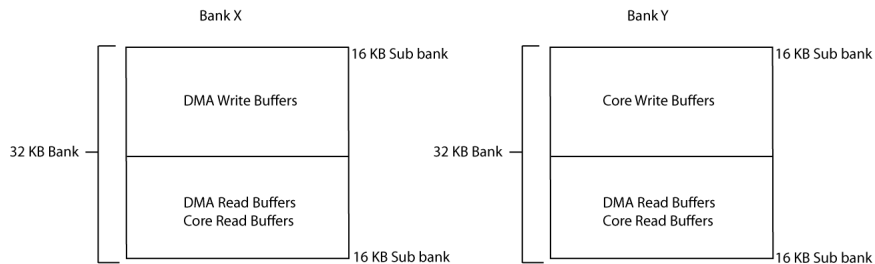
The figure shows the memory placement when DMA and Core write buffers are less than 16 KB.

1. If DMA requires less than 16 KB of data space or DMA requires between 16 KB and 32 KB of data space, but less than 16 KB for DMA writes, the workaround is to place the segregated write buffers either at the top or bottom half of the 32 KB bank. Ensure that the writable DMA data regions and read-only DMA data regions are in different half banks. Core-writable variables may be placed in the other half of the 32 KB bank that contains read-only DMA regions.

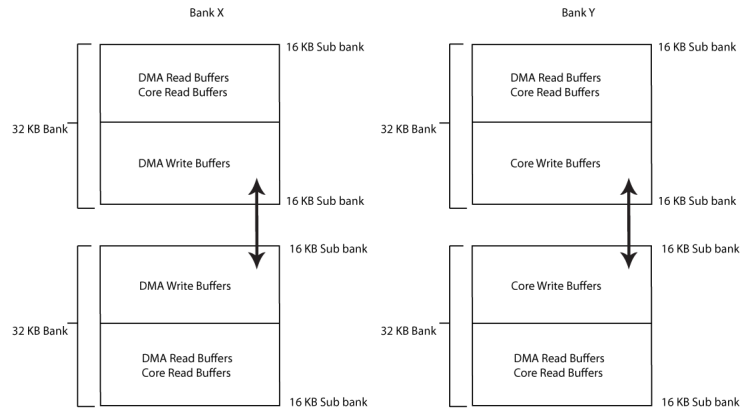
The figure shows the memory placement when DMA write buffers are between 16 KB and 32 KB.

2. If DMA requires more than 16 KB but less than 32 KB for writes, and DMA writes are a single linear stream, the workaround is to place the write data buffer in a single bank that has data in both halves of the bank. This issue does not exist in case of a linear addressed DMA. If DMA writes are not sequential and ordered and the DMA buffer requires more than 16 KB, the region must start from the higher half of the bank and continue into the lower half of the next bank. Core-writable variables may be placed in the other half of the 32 KB bank that contains read-only DMA regions.
