ABOUT ADSP-TS202S SILICON ANOMALIES

These anomalies represent the currently known differences between revisions of the TigerSHARC ADSP-TS202S product(s) and the functionality specified in the ADSP-TS202S data sheet(s) and the Hardware Reference book(s).

NR003039L

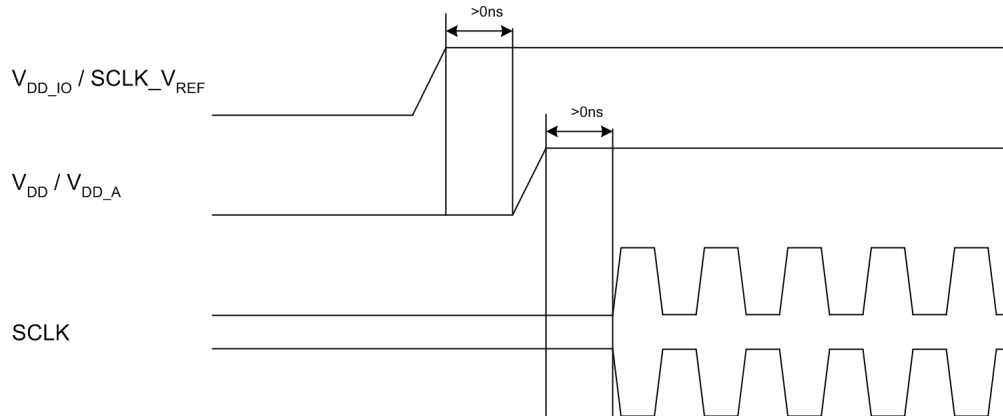
57. 03000373 - PLL Failure to Lock at Power-Up:**DESCRIPTION:**

The PLL may fail to lock correctly to the SCLK input during power-up.

V_{DD}/V_{DD_a} must be held low until after V_{DD_io} and SCLK_V_{REF} are stable and within specification. Additionally, SCLK must be held high or low until after V_{DD}/V_{DD_a} is stable and within specification. The following figure illustrates the workaround:
