Silicon Anomaly List ADSP-BF542/BF544/BF547/BF548/BF549

ABOUT ADSP-BF542/BF544/BF547/BF548/BF549 SILICON ANOMALIES

The following list details all known silicon anomalies for the ADSP-BF542/BF544/BF547/BF548/BF549 including a description, workaround, and identification of applicable silicon revisions.

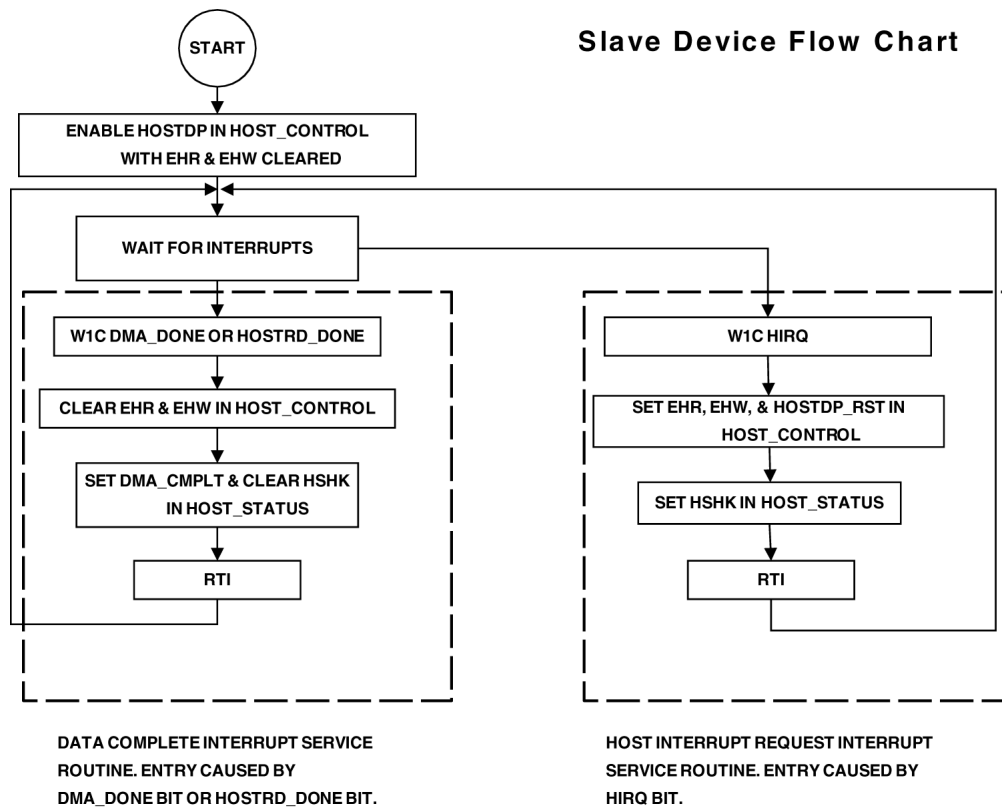
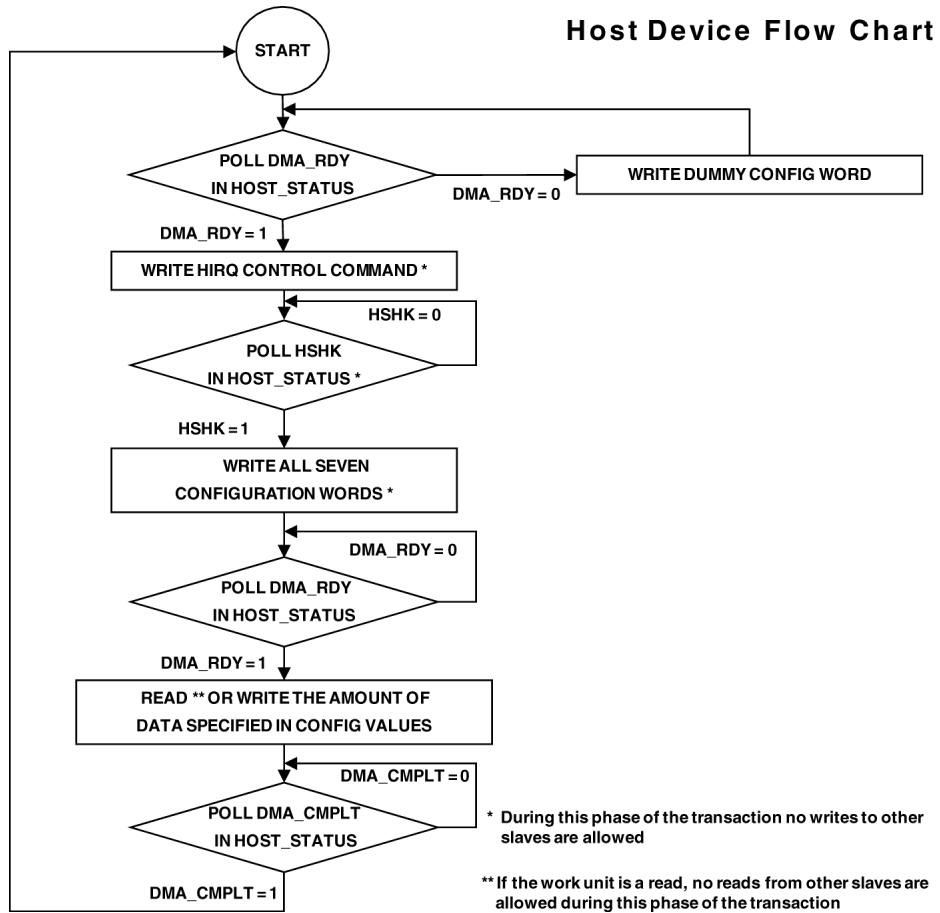
The Host DMA Port (HOSTDP) responds to certain bus activity even without the assertion of its chip enable, $\overline{\text{HOST_CE}}$. If the HOSTDP is the only slave on the bus (meaning that $\overline{\text{HOST_WR}}$ and $\overline{\text{HOST_RD}}$ are asserted by the host only for communicating with the HOSTDP), this anomaly will not be observed. There are two states in which the HOSTDP responds to bus activity (assertion of $\overline{\text{HOST_WR}}$ or $\overline{\text{HOST_RD}}$) without $\overline{\text{HOST_CE}}$ being asserted:

1. HOSTDP is Enabled and Waiting for the Host to Configure - While waiting for configuration in both acknowledge and interrupt modes, assertions of $\overline{\text{HOST_WR}}$ for other slaves can cause the HOSTDP to be erroneously configured.
2. HOSTDP is Configured for Data Reads - While waiting for data reads in both acknowledge and interrupt modes, assertions of $\overline{\text{HOST_RD}}$ for other slaves can cause the HOSTDP to subsequently return data out of order.

The following workarounds can be used for state #1:

- a. Add additional logic - Connect to $\overline{\text{HOST_WR}}$ through a 2-input OR gate where one input of the OR gate is the host's write signal and the other is the host's chip select.
- b. Time bus accesses by the host processor - Do not write to other slaves on the bus between the time that the HOSTDP is enabled and the DMA_RDY bit in HOST_STATUS is set.
- c. Change the software on both the host and the slave as shown in the following flowcharts:
