DS2155

T1/E1/J1 Single-Chip Transceiver

REVISION A3 ERRATA

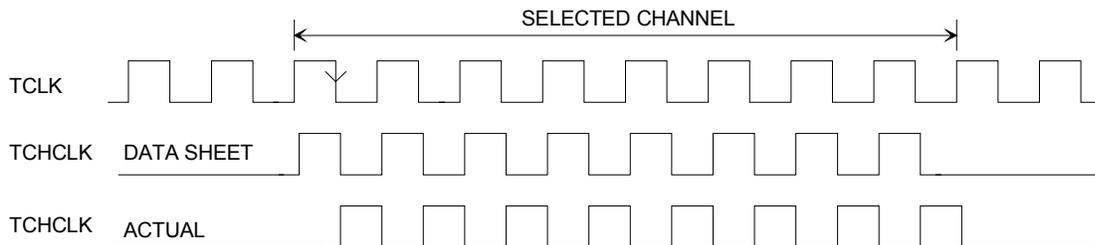
4. TRANSMIT FRACTIONAL SUPPORT

The transmit fractional support (alternate function of the TCHCLK pin) does not operate as described in the data sheet. Transmit data at the TSER pin is sampled on the falling edge of TCLK. In fractional support mode the TCHCLK pin should output a clock (gated version of TCLK) during a selected channel or channels. The rising edge of this clock could be used to present data to the TSER pin for sampling in the falling edge of TCLK. However, TCHCLK is delayed one-half clock in this rev of the DS2155. Its rising edge occurs AFTER the sampling time of the corresponding bit time of TCLK, as shown below.

There is no known software work around for this issue.

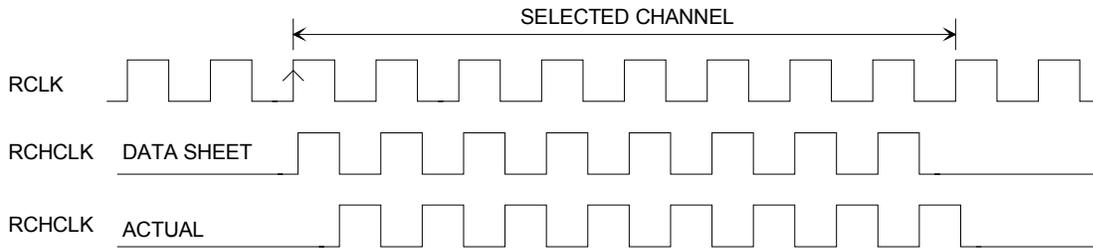
5. RECEIVE FRACTIONAL SUPPORT

The receive fractional support (alternate function of the RCHCLK pin) does not operate as described in the data sheet. Receive data at the RSER pin is updated on the rising edge of RCLK. In fractional support mode the RCHCLK pin should output a clock (gated version of RCLK) during a selected channel or channels. The falling edge of this clock could be used by the backplane to sample data output on the RSER pin. However, RCHCLK is delayed one half clock in this rev of the DS2155.

As an alternate method, the backplane can use the rising edge RCHCLK to sample data output from RSER.
