ERRATA SHEET

DS26518

Revision A2 Errata

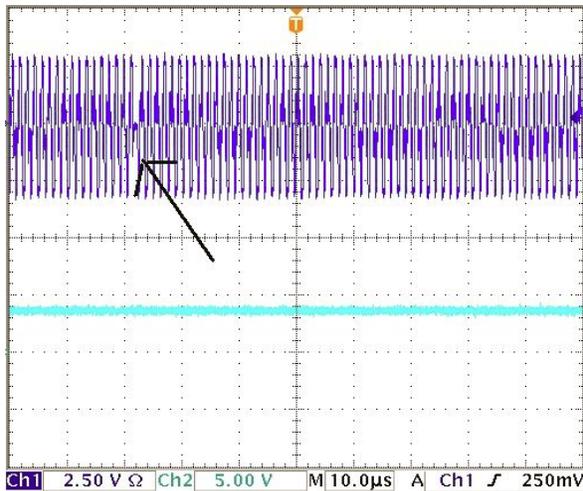
Figure 1

The TTIPn/TRINGn line drivers should be high impedance whenever TXENABLE is low. On rev A2 devices, the TTIPn/TRINGn line drivers are briefly enabled during power-up, even if TXENABLE is low. This may cause the inactive DS26518 in a Y-cable application to attenuate the transmit waveform of the active DS26518 and create a bit error, as seen in the figures below.

None.
