Anomaly Sheet for All Revisions

AD1940/AD1941

1. Incorrect Polarity of Serial Input Port Left-Justified Mode [er001]

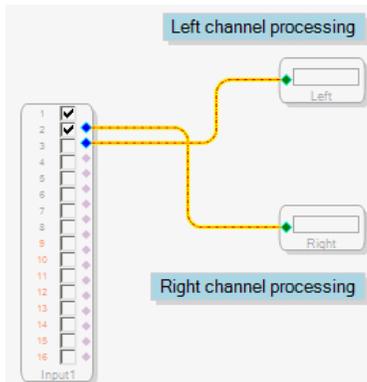
Figure 1. Swapping Channels in SigmaStudio

Issue: When the AD1940/AD1941 serial input port is set to left-justified mode with left-justified formatted data being input to the part, the channels will be swapped. This means that in the SigmaDSP core the left channel data is present when LRCLK is low, and the right channel data shows on the high half of the LRCLK frame.

1. The easiest solution for this problem is to simply flip the channels from the serial input block in SigmaStudio™. In this case, the serial input control register should be set up properly for left-justified mode, as described in the Data Format Configurations table in the AD1940/AD1941 data sheet. Figure 1 shows how this can be done in SigmaStudio. If SDATA_IN0 is used in left-justified mode, then SigmaStudio Input 1 is the right channel data, and SigmaStudio Input 2 is the left channel data. This is the reverse of what is expected in left-justified mode.
