MAX96714/MAX96714F/MAX96714R DEV_REV=1 (A-0B) ERRATA SHEET

Corresponds to data sheet 19-101134; Rev2; 05/23

DEV_REV=1 (per reading of register 0x0E)

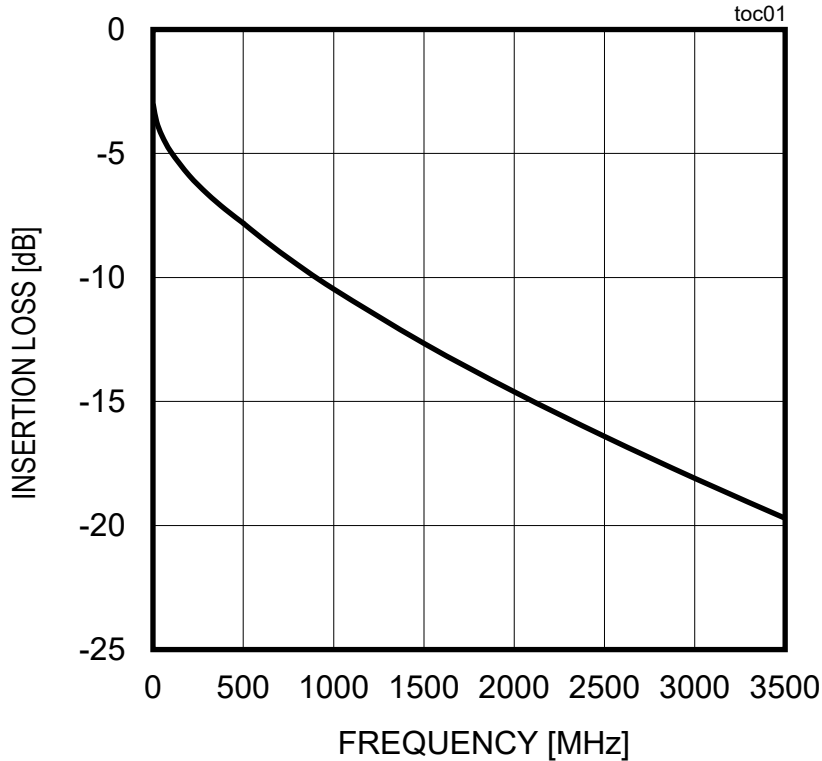
MAX96714 MAX INSERTION LOSS
GMSL2 CHANNEL PIN-to-PIN (6Gbps)

9) Additional information for 6Gbps Insertion Loss Channel Specification (Errata ID = 830005)

The data sheet specifies 6Gbps insertion loss as a single point of -18dB at 3GHz. To fully specify the 6Gbps insertion loss channel specification, the following plot and equations are provided as additional information.

$$IL(f[Hz]) = \begin{cases} -\left(2.74 + 0.21\sqrt{(f \times 10^{-6})} + 0.54 (f \times 10^{-9})\right) & \text{for } 2 \text{ MHz to } 500 \text{ MHz} \\ -\left(2.35 + 0.21\sqrt{(f \times 10^{-6})} + 1.34 (f \times 10^{-9})\right) & \text{for } 500 \text{ MHz to } 3.5 \text{ GHz} \end{cases}$$

None required

Datasheet revision is planned
