MAX96724/MAX96724F/MAX96724R DEV_REV=1 (B-0A) ERRATA SHEET

Corresponds to Data sheet 19-101575; Rev 4; 1/2023 Errata

DEV_REV=1 (per reading of register 0x4C)

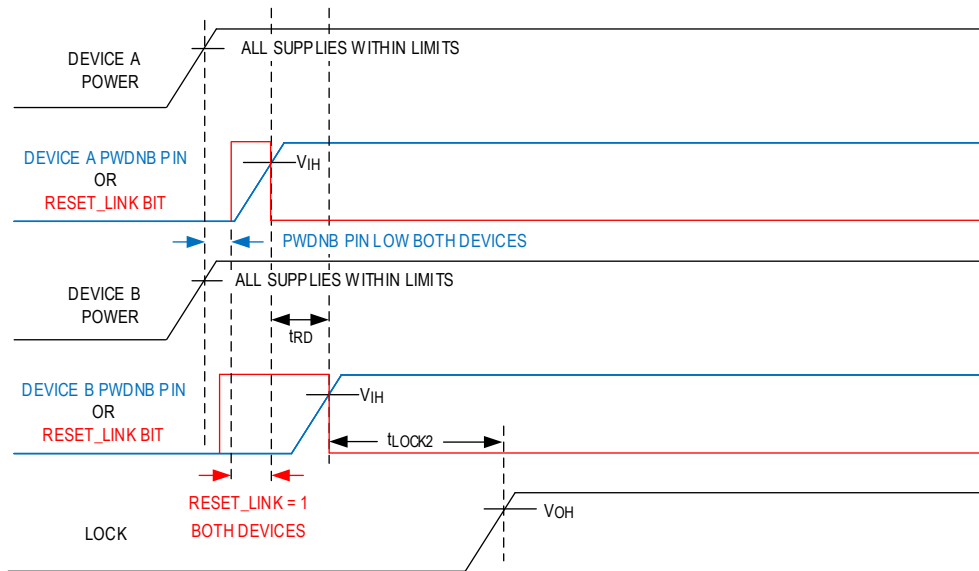
4) GMSL link lock times may increase if DES and SER are powered up or released from reset with significant delay relative to each other

Due to timeouts in the link layer, GMSL link lock times (t_{LOCK2}) may increase above 160ms¹ (or 200ms²) if deserializer (DES) and serializer (SER) links are powered up or released from reset with more than 90ms¹ (or 70ms²) delay (t_{RD}) relative to each other. This issue applies only if the SER is released from reset first.

In certain configurations, devices must be programmed after the power-up (e.g. to set the link rate) and the link must be reset to trigger the configuration change. As the user-issued link resets may interrupt on-going link lock attempts, it is critical to ensure that link resets are issued on both SER and DES sides and are overlapping in time as shown on the diagram below. Without overlapping resets of both SER and DES devices, one of the devices may have to wait to complete its timeout sequence before it becomes available for the next link lock attempt. Overlapping link resets on SER and DES devices should be released within t_{RD} time window relative to each other if the SER is released from reset first, similar to the power up t_{RD} requirement.

1. Implement DES and SER programming sequence such that DES is powered up or released from link reset before SER. If link resets are used, make sure that they overlap.
2. If SER is powered up or released from link reset after DES, implement DES and SER programming sequence to power up or release DES and SER link resets within $t_{RD} < 90\text{ms}$ (or $t_{RD} < 70\text{ms}$) of each other. If link resets are used, make sure that they overlap.
3. If workarounds #1 or #2 cannot be used, contact factory for further guidance on optimizing the lock time.
