MAX96724/MAX96724F/MAX96724R DEV_REV=1 (B-0A) ERRATA SHEET

Corresponds to Data sheet 19-101575; Rev 4; 1/2023 Errata

DEV_REV=1 (per reading of register 0x4C)

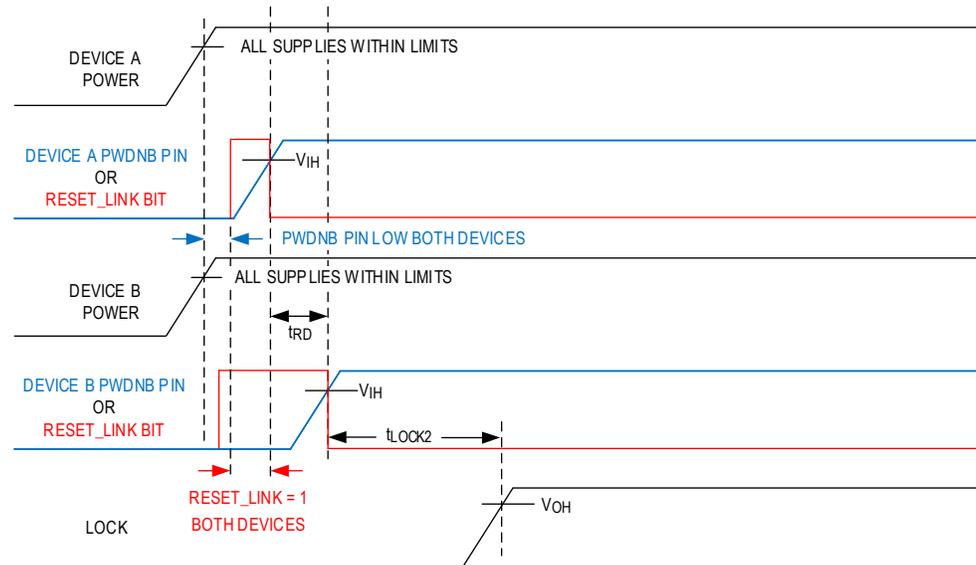
Due to timeouts in the link layer, GMSL link lock times (t_{LOCK2}) may increase above 160ms¹ (or 200ms²) if deserializer (DES) and serializer (SER) links are powered up or released from reset with more than 90ms¹ (or 70ms²) delay (t_{RD}) relative to each other. This issue applies only if the SER is released from reset first.

In certain configurations, devices must be programmed after the power-up (e.g. to set the link rate) and the link must be reset to trigger the configuration change. As the user-issued link resets may interrupt on-going link lock attempts, it is critical to ensure that link resets are issued on both SER and DES sides and are overlapping in time as shown on the diagram below. Without overlapping resets of both SER and DES devices, one of the devices may have to wait to complete its timeout sequence before it becomes available for the next link lock attempt. Overlapping link resets on SER and DES devices should be released within t_{RD} time window relative to each other if the SER is released from reset first, similar to the power up t_{RD} requirement.

1. Implement DES and SER programming sequence such that DES is powered up or released from link reset before SER. If link resets are used, make sure that they overlap.
2. If SER is powered up or released from link reset after DES, implement DES and SER programming sequence to power up or release DES and SER link resets within $t_{RD} < 90\text{ms}$ (or $t_{RD} < 70\text{ms}$) of each other. If link resets are used, make sure that they overlap.
3. If workarounds #1 or #2 cannot be used, contact factory for further guidance on optimizing the lock time.
