LTC4302-1/LTC4302-2 LTC4305, LTC4306, I²C Filter SDAIN Short Pulse Misprocessing Issue

October 5, 2011

Date Codes for New LTC4302-1/LTC4302-2, LTC4305, LTC4306 Silicon with Fixed Input I²C Filter Circuitry

Product Errata

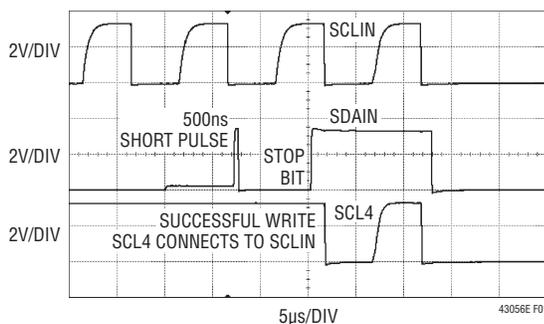
Figure 1. A 500ns Wide Logic High Short Pulse on SDAIN Causes No Issues with the LTC4306. After the Stop Bit, Which Completes the Command to Connect to Channel 4, SCL4 Follows SCLIN as It Should

the problem using the LTC4306. The same SCLIN and SDAIN waveforms shown in the figures can cause similar problems in the LTC4302-1/LTC4302-2 and LTC4305. Figure 1 shows a successful write operation to connect the input SDAIN, SCLIN bus to downstream channel 4. The SDAIN short pulse is 500ns wide—wider than the maximum 340ns pulse width that can ever cause a misprocessing issue. SDAIN short pulses narrower than 150ns also never cause an issue.

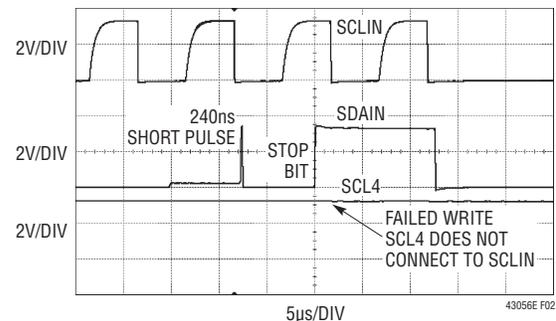
Figure 2 shows a failed write operation to connect to downstream channel 4, where SCL4 remains high after the Stop Bit. The SDAIN short pulse width that caused the problem for this particular unit was 240ns. Pulse widths narrower than 237ns and wider than 243ns resulted in successful write operations.

Figure 2. A 240ns Wide Logic High Short Pulse on SDAIN Causes a Failed Write Operation to Occur with the LTC4306. After the Stop Bit, Which Completes the Command to Connect to Channel 4, SCL4 Fails to Connect to SCLIN and Remains High. For the Unit Under Test, if the Short Pulse Width Is Narrowed to Less Than 237ns or Widened to Greater Than 243ns, the Write Operation Is Successful

Because the ±3ns window causing the problem is so small, random variations in the system over time can cause the problem to be intermittent. For this reason, a Write Operation to a single LTC4302-1/LTC4302-2, LTC4305, LTC4306 may fail sometimes but pass at other times. The best way

to fix this issue is to ensure that the SDAIN short pulse never occurs. Adding capacitance to SDAIN to prevent the short pulse from rising above 1V is a good solution. This and other solutions are discussed in the next section.

- Observe the SDAIN short pulses before and after the 9th clock of each byte when the master is communicating with the LTC4302-1/LTC4302-2, LTC4305, LTC4306. Add capacitance to the SDAIN line to prevent SDAIN from ever rising above 1V during a short pulse. Adding the same capacitance to SCLIN is also recommended to optimize timing on the I²C bus.

- For a given unit, the time window in which the problem occurs is quite narrow – on the order of a few nanoseconds. Due to the narrow time window coupled with random cycle-to-cycle variations, a write operation that fails on the first attempt will often succeed on subsequent attempts. While less than optimal and not guaranteed to work in all cases, adding a software loop to write a register, read back the register contents to confirm the new data, and retry the write if the previous write failed, often fixes the problem.
