Reliability Report

Report Title: AD5941/AD5943 Automotive Grade
2 Qualification

Report Number: 14989

Date: 11 October 2021

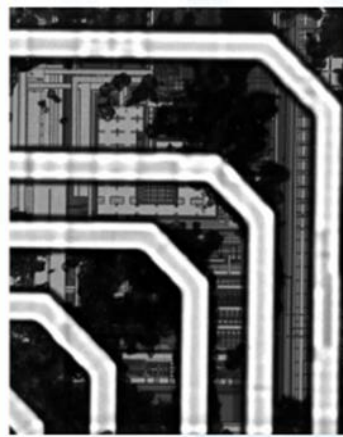
SN396

Emission Microscopy enables the location of sublayer defects through detection of faint light levels emitted from silicon device structures. These faint light levels arise from recombinant radiation emitted from p-n junctions and from oxides. Photon emission analysis was performed on the failing unit to further isolate the location of the suspected defect, while biasing the unit in the failing state. Abnormal emission site was observed on the internal circuitry near the xtal pins. This block is supplied by DVDD pin.

LEM result of the failing unit comparable with the results from a known good unit

⁴ FA#220584: Post-ELF failure. One unit failed at the Hibernate DVDD_AD Sensor Bias Gross IDD test at both Ambient and Hot temperature. Complete physical analysis confirmed abnormal emission site in the circuit block near the Xtal pins. Cross-section using the Focused Ion Beam (FIB) confirmed the defect on a poly capacitor connected to 1.8V DVDD and GND. Feedback is that this was a fab defect and likely caused by an anomaly during the OD (operation domain) etch process at TSMC. A tool particle dropped on the wafer during the etch process caused a residue that would make extra OD pattern and caused poor isolation. The TSMC improvement plan of enhancing the process by improving the etch chamber condition and cleanliness of the OD etcher tool can help reduce or eliminate the OD flat type defects.

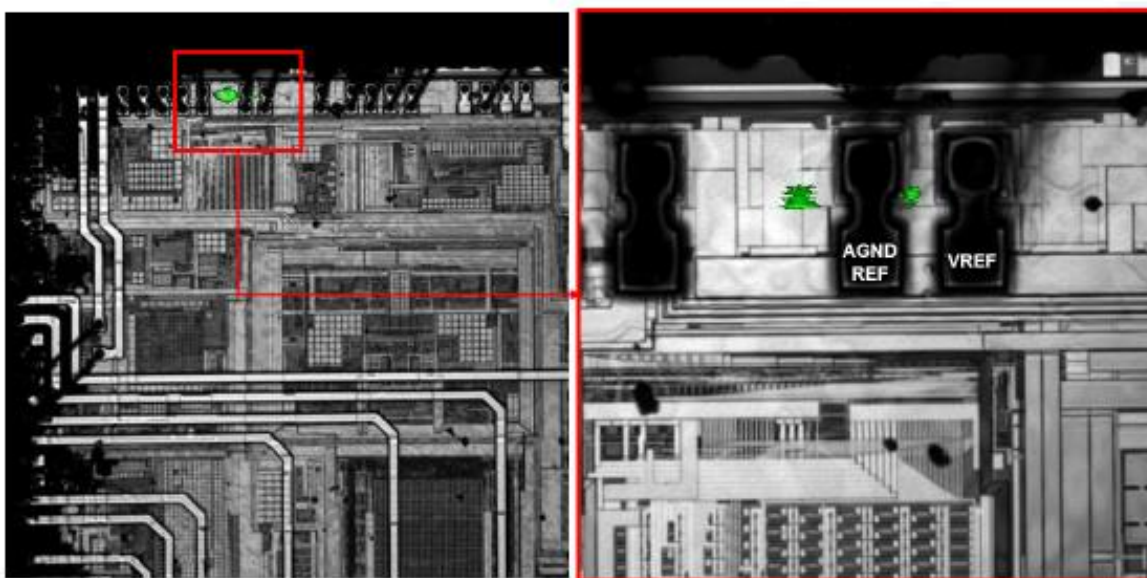
Optical Beam Induced Resistance Change (OBIRCH) identifies the failure location by scanning the surface of the die using an infrared laser and then detecting any changes in resistance value caused by the laser. Extremely small changes in resistance can be observed due to localized heating caused by the laser. The unit was analyzed using OBIRCH, using the abnormal leakage on Pin43 (VREF) to activate the failure mode. Abnormal resistance-changing site or hotspot was detected on the circuitry connected to the shorted pins; see Figure 2.

Figure 2. Image of the abnormal resistance-change or hotspot observed on the unit

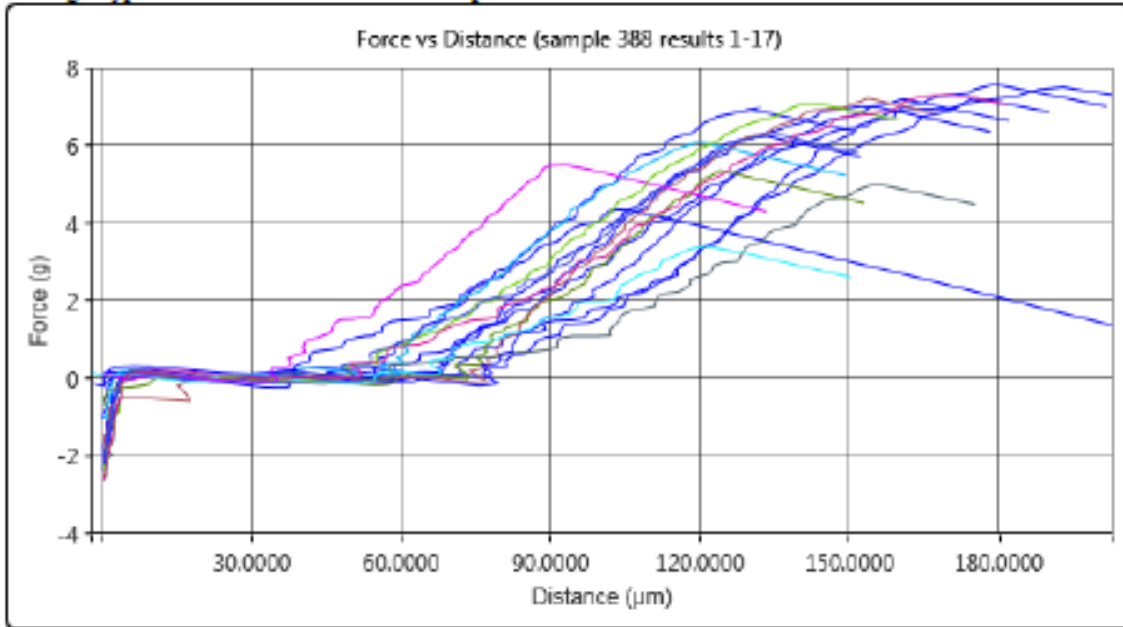
Test Group: BOND PULL
Operator: Default operator
Test Speed: 500.00 $\mu\text{m/s}$
Test Load: 25.000 g
Machine: 20184717
Cartridge serial number: 20184517
Date saved: 9/1/2021 9:22:09 AM
Total number of tests: 17
Product type: AD5941 (Q14989.TC2) #1 BOND PULL
Package Type: 48 lfcsp

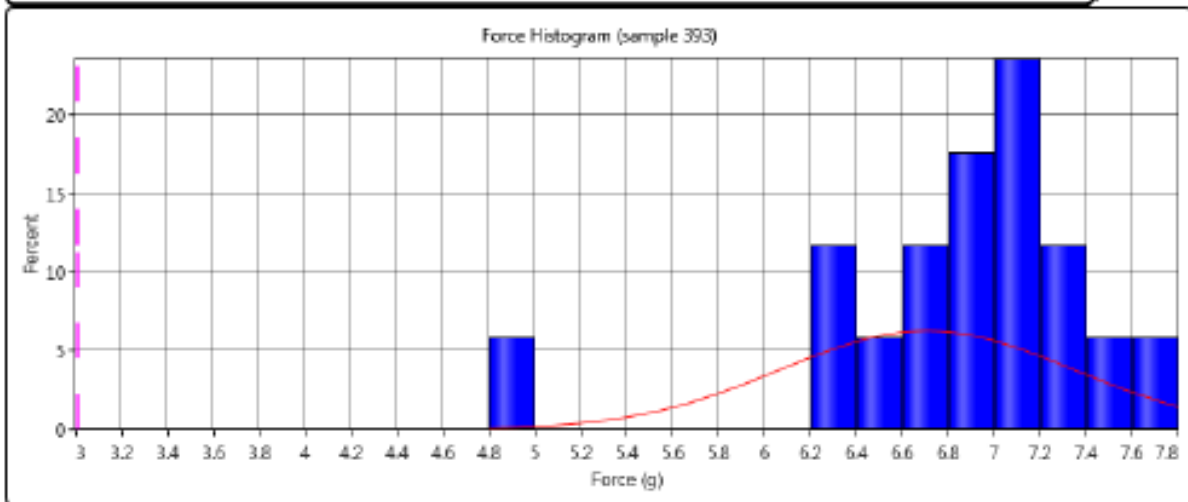
Test Group: BOND PULL
Operator: Default operator
Test Speed: 500.00 $\mu\text{m/s}$
Test Load: 25.000 g
Machine: 20184717
Cartridge serial number: 20184517
Date saved: 9/9/2021 12:27:21 PM
Total number of tests: 17
Product type: AD5941 (Q14989.TC3) #1 BOND PULL
Package Type: 48 lfcsp

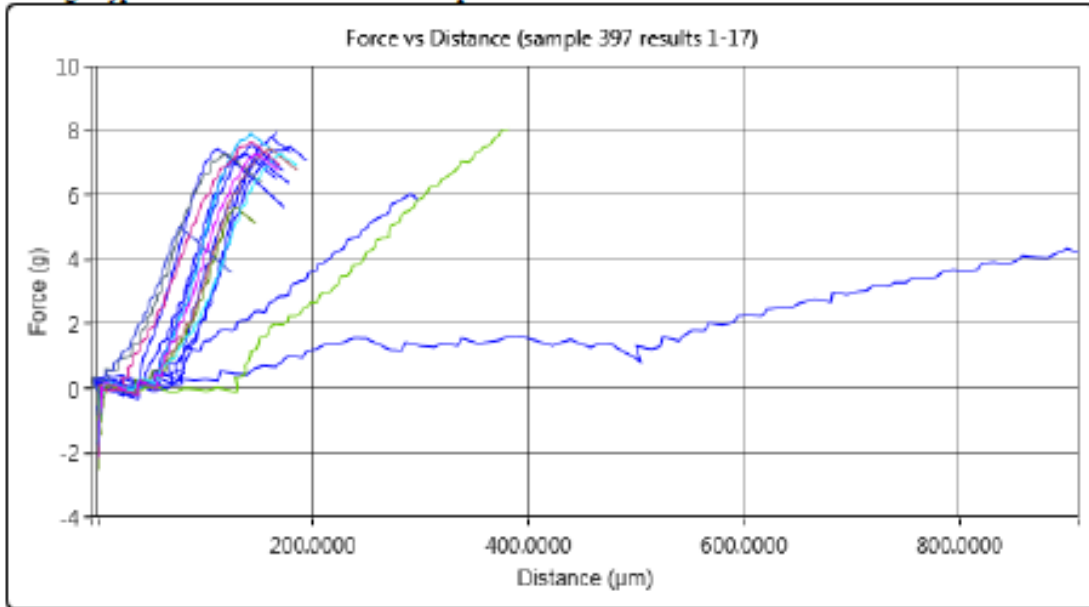
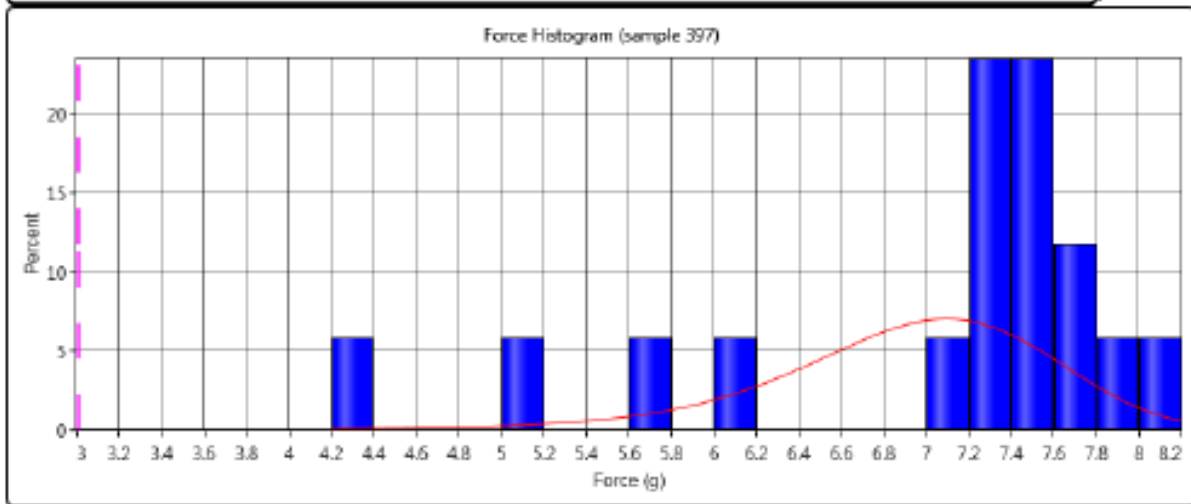
Test Group: BOND PULL
Operator: Default operator
Test Speed: 500.00 $\mu\text{m/s}$
Test Load: 25.000 g
Machine: 20184717
Cartridge serial number: 20184517
Date saved: 9/9/2021 1:04:29 PM
Total number of tests: 17
Product type: AD5941 (Q14989.TH1A) #2
BOND PULL
Package Type: 48 lfcsp

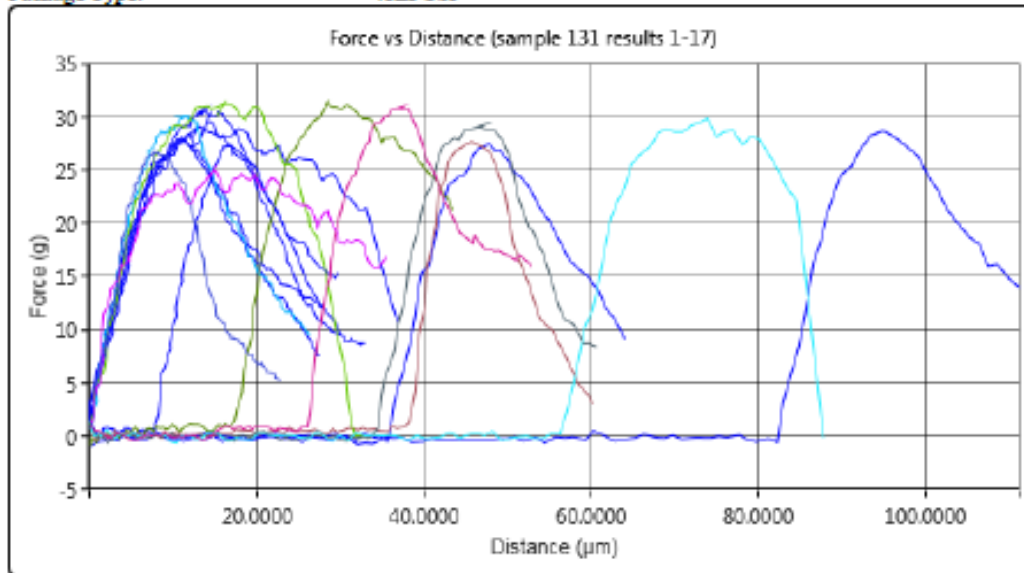
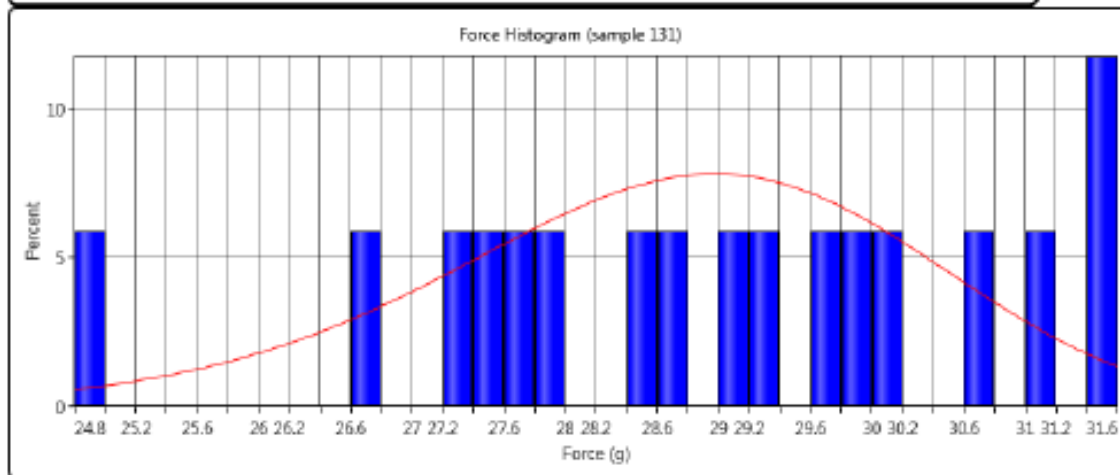
Test Group: S5KG-BALLBOND_SHEAR
 Operator: Default operator
 Test Speed: 500.00 $\mu\text{m/s}$
 Shear height: 3.0000 μm
 Test Load: 400.00 g
 Machine: 20184717
 Cartridge serial number: 20184117
 Date saved: 6/15/2021 11:07:57 AM
 Sample number: 131
 Total number of tests: 17
 Product type: ad5941 (Q14989.TC1) DIE #6
 Package Type: 48LFCSP

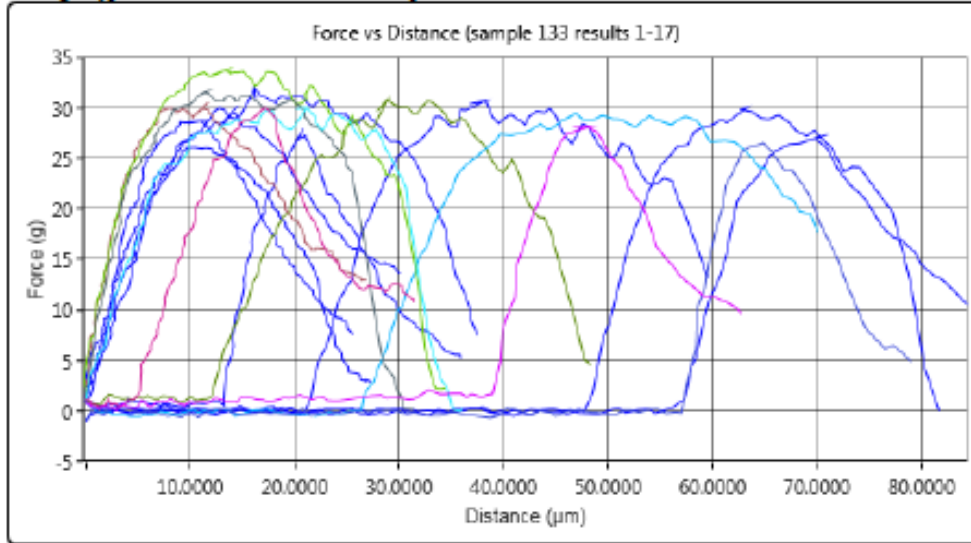
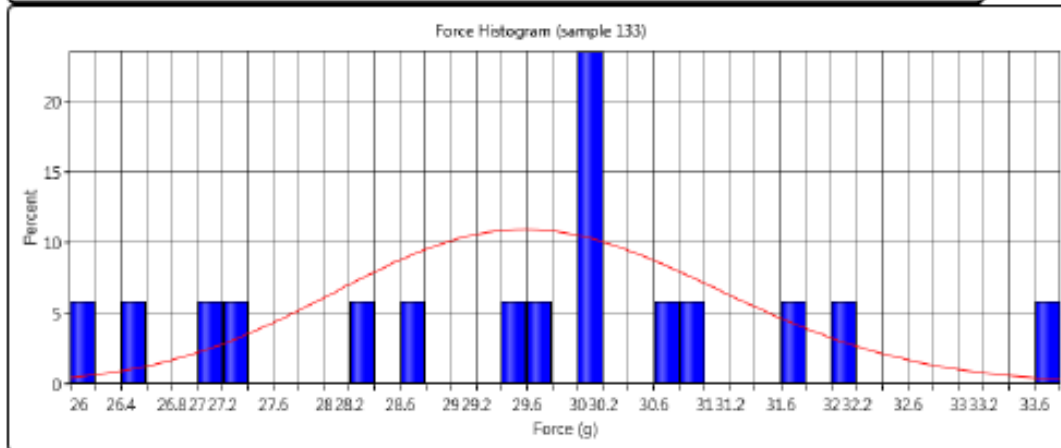
Test Group: S5KG-BALLBOND_SHEAR
Operator: Default operator
Test Speed: 500.00 $\mu\text{m/s}$
Shear height: 3.0000 μm
Test Load: 400.00 g
Machine: 20184717
Cartridge serial number: 20184117
Date saved: 6/15/2021 11:30:32 AM
Sample number: 133
Total number of tests: 17
Product type: AD5941 (Q14989.TC1) DIE #8
Package Type: 48 lfcsp

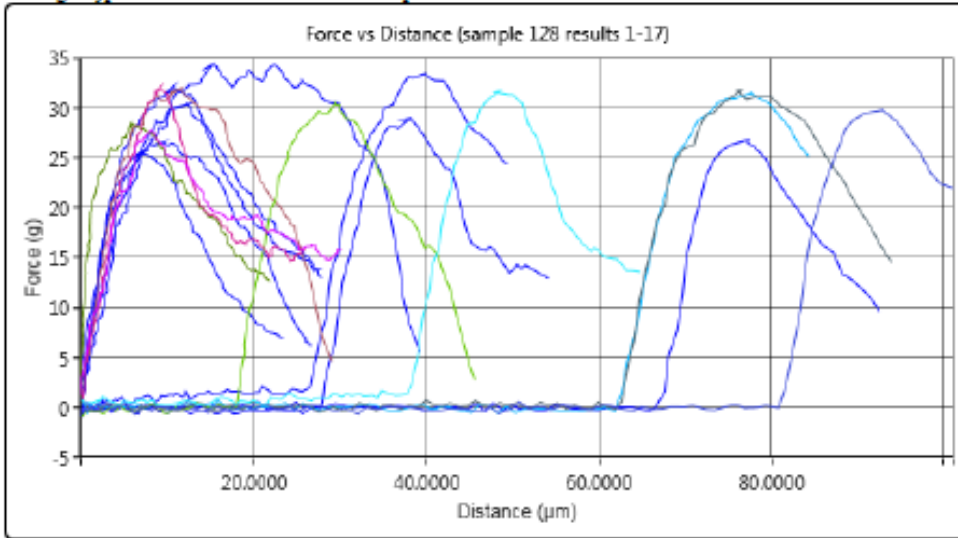
Test Group: S5KG-BALLBOND_SHEAR
 Operator: Default operator
 Test Speed: 500.00 $\mu\text{m/s}$
 Shear height: 3.0000 μm
 Test Load: 400.00 g
 Machine: 20184717
 Cartridge serial number: 20184117
 Date saved: 6/15/2021 10:23:03 AM
 Sample number: 128
 Total number of tests: 17
 Product type: ad5941 (q14989.th2) die #6
 Package Type: 48 lfcsp

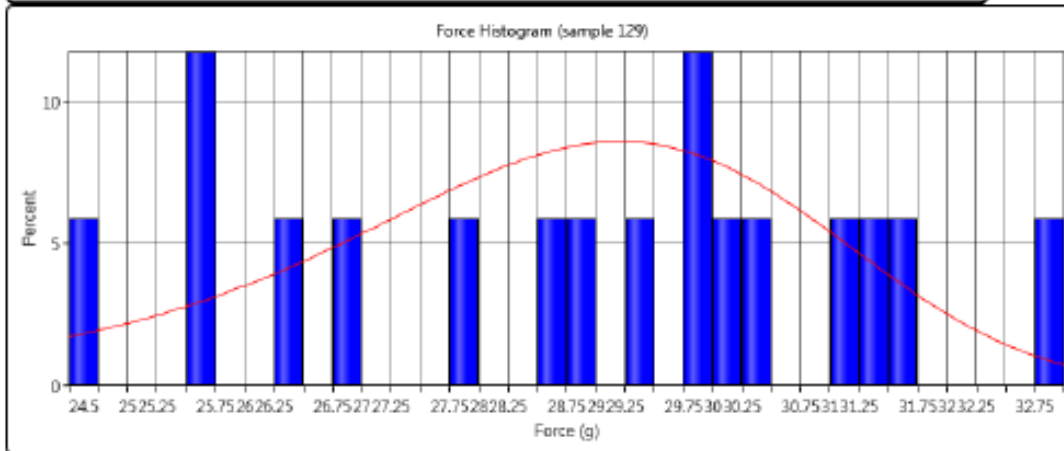
Test Group: SSKG-BALLBOND_SHEAR
Operator: Default operator
Test Speed: 500.00 $\mu\text{m/s}$
Shear height: 3.0000 μm
Test Load: 400.00 g
Machine: 20184717
Cartridge serial number: 20184117
Date saved: 6/15/2021 10:34:18 AM
Sample number: 129
Total number of tests: 17
Product type: ad5941 (q14989.th2) die #7
Package Type: 48 lfcsp

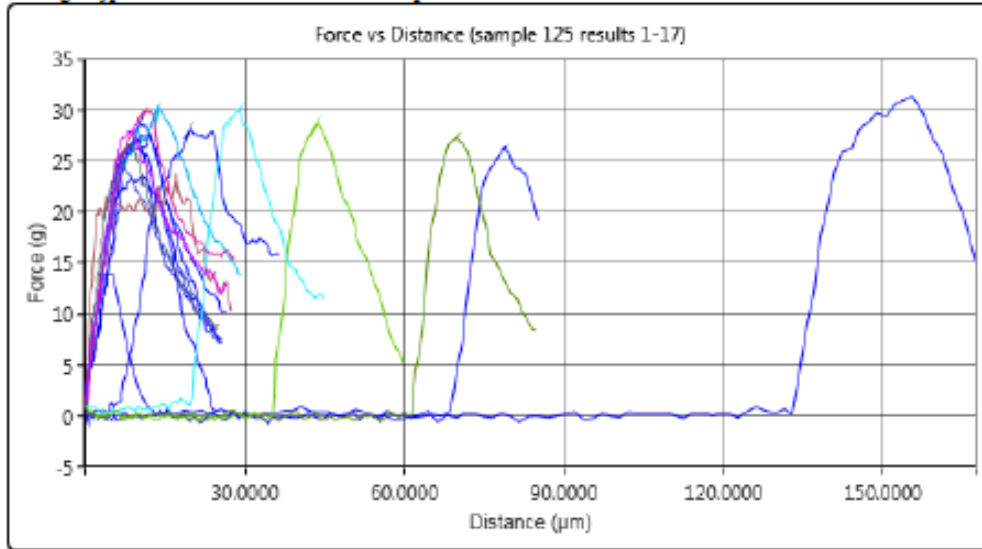
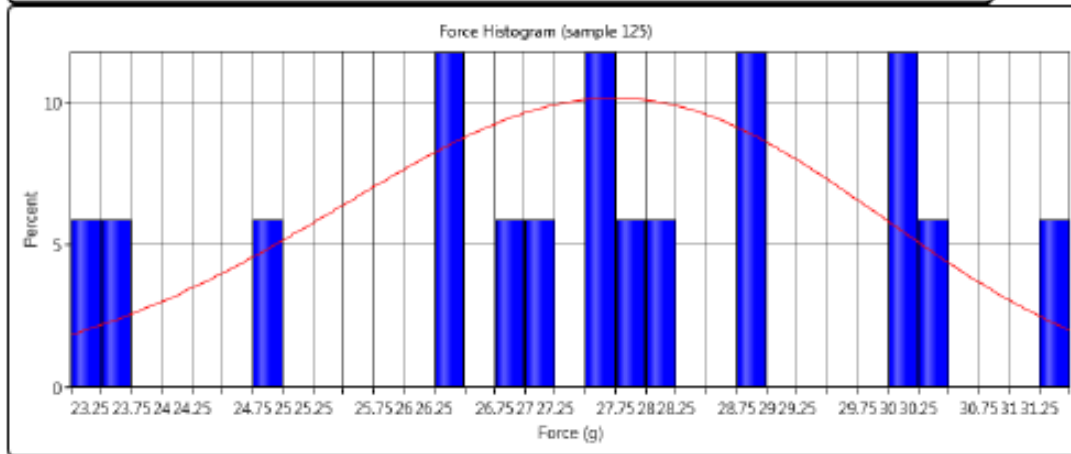
Test Group: SSKG-BALLBOND_SHEAR
Operator: Default operator
Test Speed: 500.00 $\mu\text{m/s}$
Shear height: 3.0000 μm
Test Load: 400.00 g
Machine: 20184717
Cartridge serial number: 20184117
Date saved: 6/15/2021 9:19:56 AM
Sample number: 125
Total number of tests: 17
Product type: ad5941 (q14989.th3) die #6
Package Type: 48 lfcsp
