Real-World Charged Board Model (CBM) Failures

Analog Devices, Inc.

Abstract – ICs that are robust to ESD at the component-level may be damaged by ESD at the board-level. Two case studies show that real-world Charged Board Model (CBM) ESD damage is typically more severe than HBM or CDM damage. Consequently, CBM damage can be easily mistaken for EOS damage. A high-capacitance yet compact PCB evaluation board facilitates qualitative CBM testing using conventional CDM test systems. Based on the case studies and CBM test results, guidelines are provided on how to minimize the likelihood of real-world CBM failures.

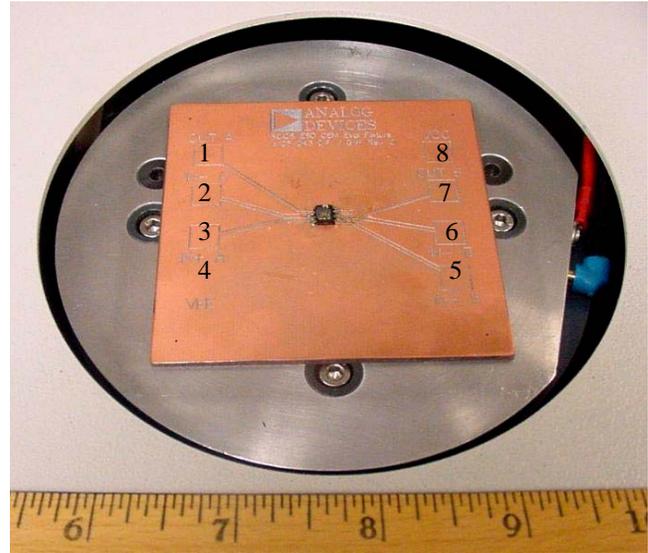
Figure 2: FICBM test method setup for the Evaluation Board with the decapsulated Dual Op Amp and eight labeled test pads.

For three samples that were FICBM tested as per the previous section (III.A.3), no degradation occurred to the Dual Op Amps after $\pm 250\text{V}$ stressing but leakage was detected between pads 2 (-IN A) and 4 (V-) after -375V stressing. On three new samples that were FICBM tested at $\pm 500\text{V}$, a resistive short of $<100\Omega$ occurred between pads 2 and 4 after -500V stressing. FA of the -500V FICBM failures consistently revealed emission sites at the anode of the input EOS/ESD protection diode between pins 2 and 4. Subsequent de-processing revealed silicon damage and melted / reflowed AlCu at this protection diode (see Figure 3). Thus, FICBM testing at -500V successfully replicated the failure mode and failure mechanism observed on the real-world board failures (reference Figure 1). CBM stressing of fresh samples at higher voltages resulted in severe damage that could easily be mistaken for EOS damage. Figure 4 shows the catastrophic damage at the input EOS/ESD protection diode after -625V FICBM stressing. For negative charge voltage magnitudes of 625V and above, the AlCu anode interconnect was completely fused open.

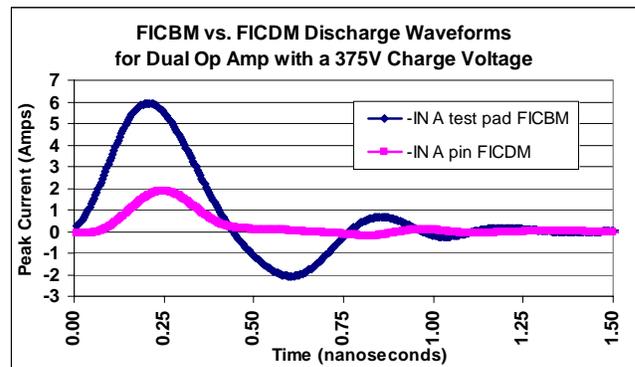
Figure 5 shows a comparison of the 375V discharge waveforms at pin 2 on a stand-alone Dual Op Amp (i.e., a FICDM discharge) versus test pad 2 when the Dual Op Amp was on the full-size Evaluation Board (i.e., a FICBM discharge). For a given charge voltage, the peak current during a CBM discharge was much higher than a CDM discharge. Also, the FICBM discharge waveform in Figure 5 has a faster rise time than the device (FICDM) discharge waveform due to the lower inductance and resistance of the board discharge path.

Figure 5: Comparison of FICBM vs. FICDM discharge waveforms at Dual Op Amp pad / pin 2 showing the higher energy in the CBM event for the Evaluation Board shown in Figure 2.

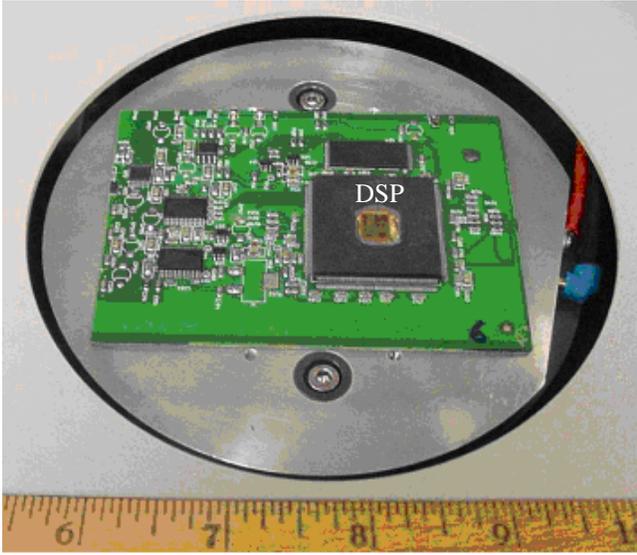
1. The cut-down PCB was centered on the charging plate (see Figure 8). Fortunately, the PCB had no components on the bottom side, so it rested flat on the charging plate. In this configuration, the capacitance measured between the PCB ground planes and the charging plate was $\sim 420\text{ pF}$, while the capacitance between the PCB Vdd plane and the charging plate was $\sim 460\text{ pF}$.

Figure 8: FICBM test method setup for the cut-down customer production board with the decapsulated DSP. The cuts were made along the top and left side of the PCB. Note that the DSP is located near the original corner of the PCB.

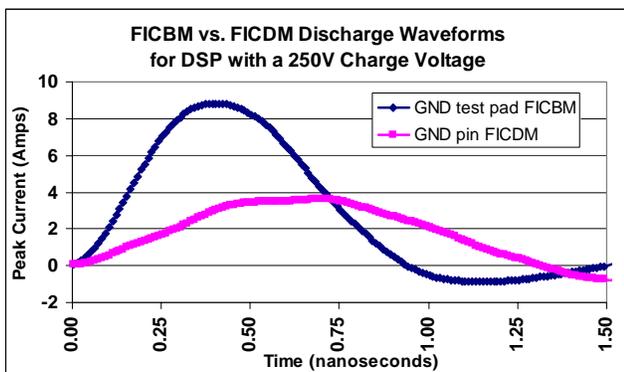
During component-level CDM testing of the DSP in a 208-lead MQFP package, the capacitance measured between a Vdd pin and the charging plate was $\sim 25\text{ pF}$. However, during CBM testing of this IC on the cut-down customer production board shown in Figure 8, the capacitance between the Vdd plane and the charging plate was $\sim 460\text{ pF}$. Thus, for a given charge voltage, the peak current during a CBM discharge was much higher than a CDM discharge. This can be seen in Figure 11 which shows a comparison of the 250V discharge waveforms at a ground pin on a stand-alone DSP (i.e., a FICDM discharge) versus a GND test pad when the DSP was on the cut-down board (i.e., a FICBM discharge) with all 35 GND and 33 Vdd pins connected to the PCB power planes. As with the Case Study 1 waveforms in Figure 5, note that the Case Study 2 board discharge waveform has a faster rise time than the device discharge waveform due to the lower inductance and resistance of the board discharge path.

Figure 11: Comparison of FICBM vs. FICDM discharge waveforms at a DSP ground pad / pin showing the higher energy in the CBM event for the cut-down PCB shown in Figure 8.
